John Winthrop Middle School

The John Winthrop Middle School

1 Winthrop Road

Overview

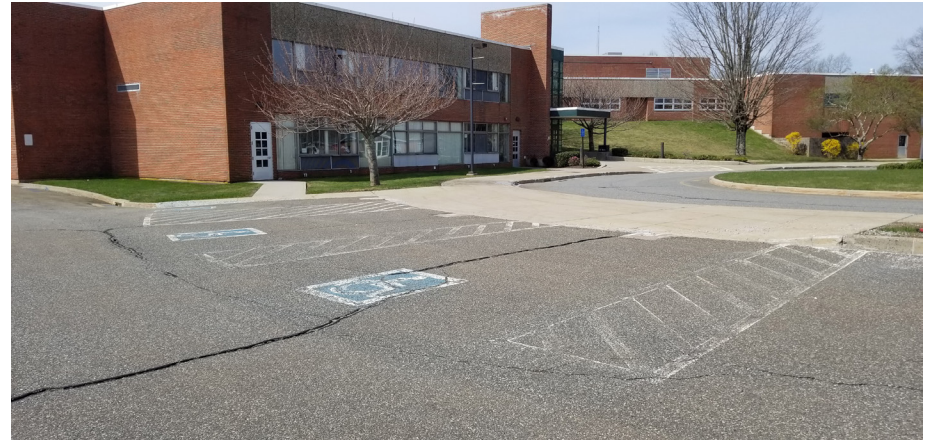
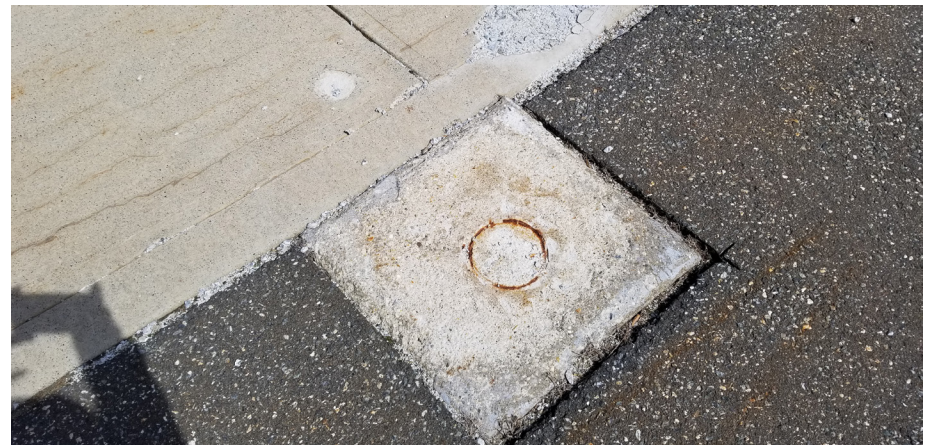
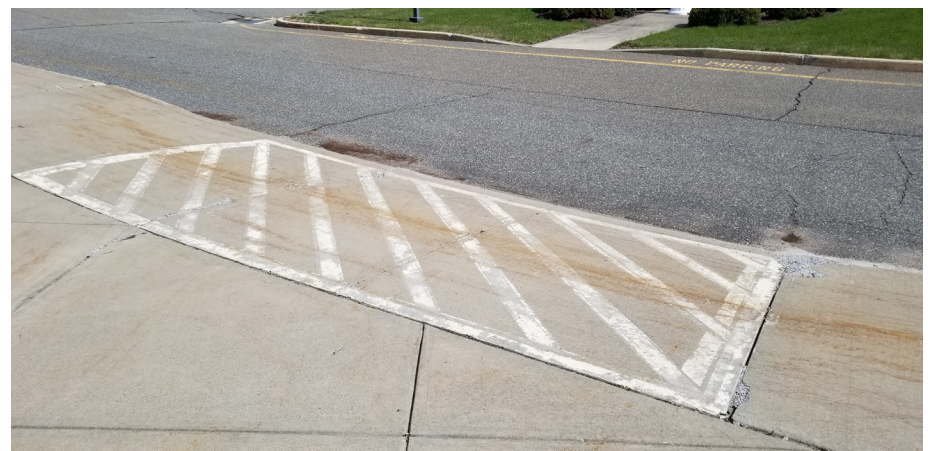
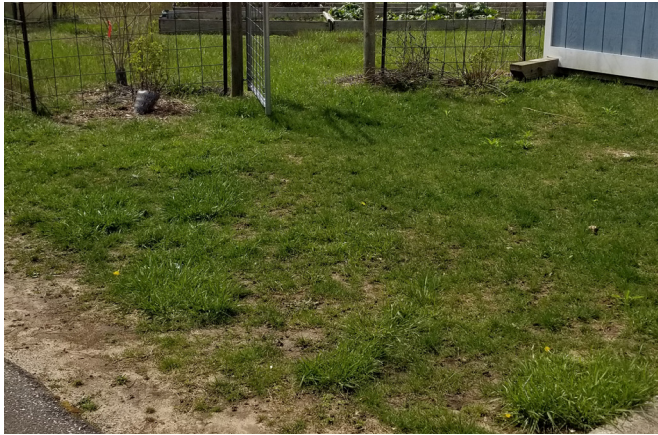
Site access and driveways throughout the site appear to be all the same age. Pavement is in fair condition throughout the site, with cracking and deterioration beginning to grow. Repaving of the site should be on track for consideration in the next 5 - 10 years.

The accessible routes are not properly constructed or marked. There are designated ADA spaces on the east and south sides of the building. These appear to be properly sized for van loading and car use. However, the required crosswalks, signs, markings, and tactile warning strips are either faded, missing, or broken, taking these spaces out of compliance. This should be addressed as a first order item. Most of the corrections are straight-forward to implement.

The curbing and sidewalks immediately the north of the building entrance are concrete. Deterioration is spreading quickly in some areas and some of the walks are becoming unsafe. Deterioration will typically accelerate once it has begun. Remedial work should be scheduled in the next two years.

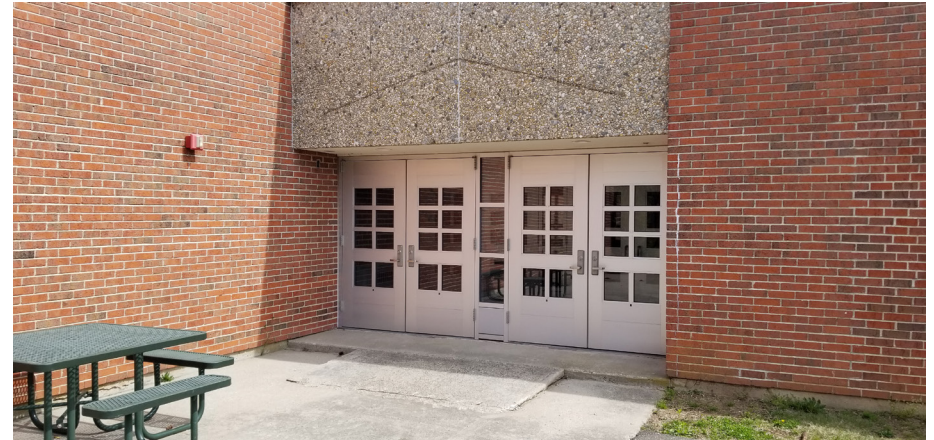
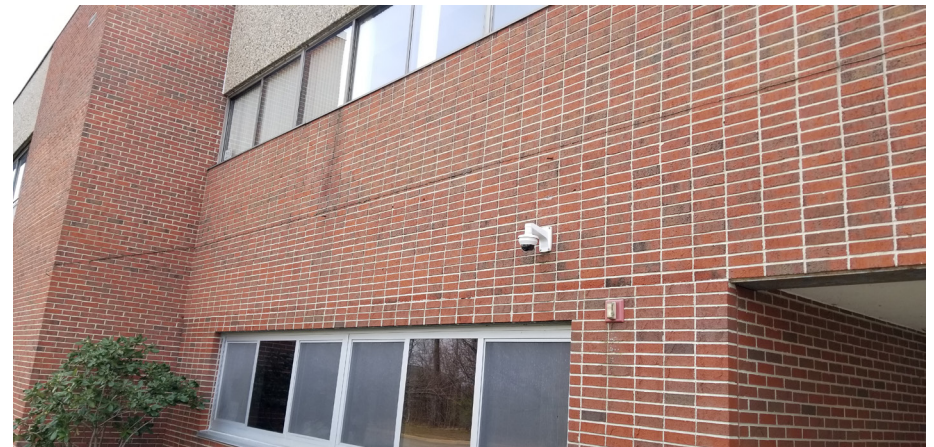
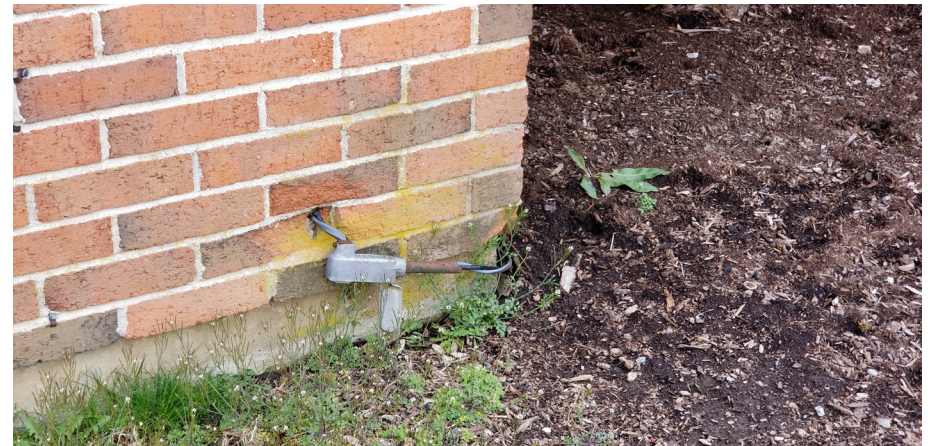
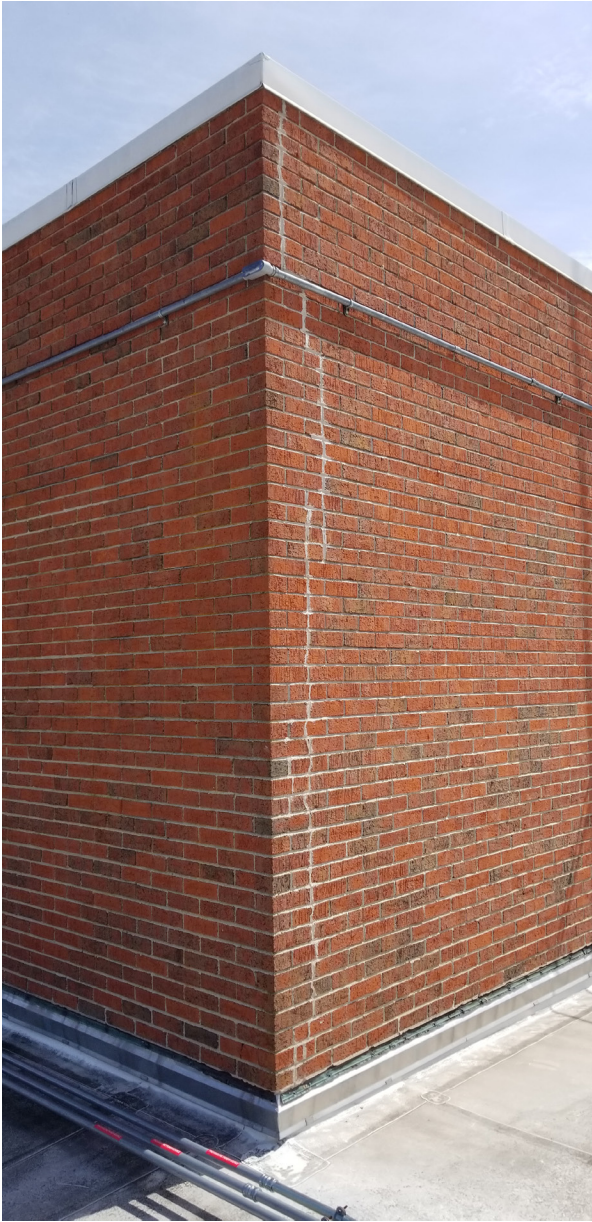
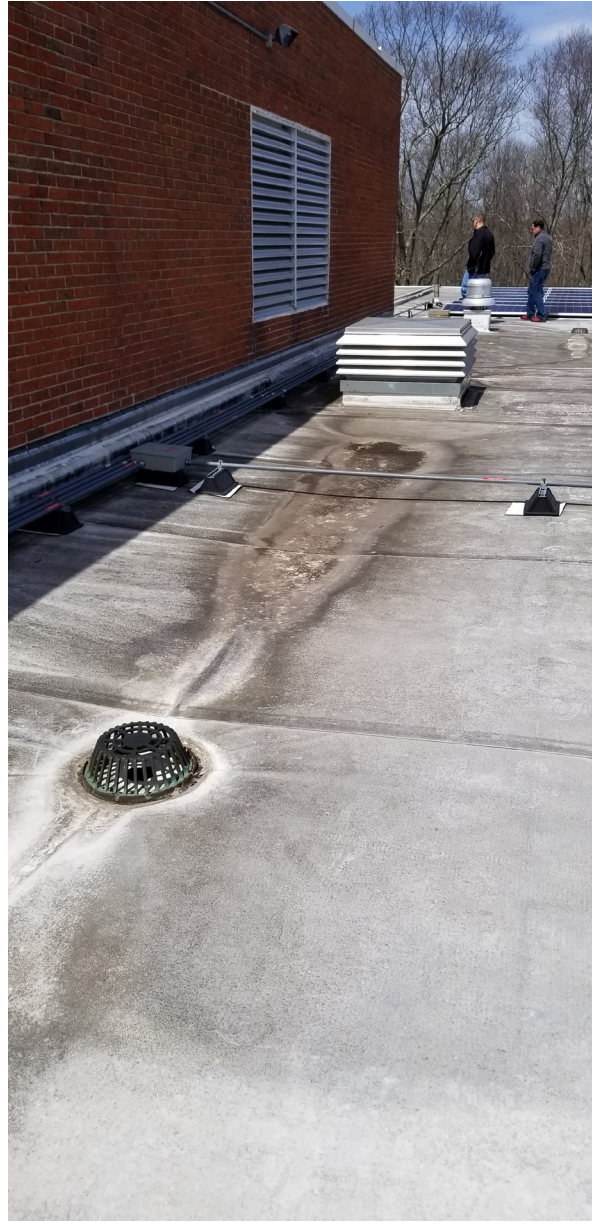
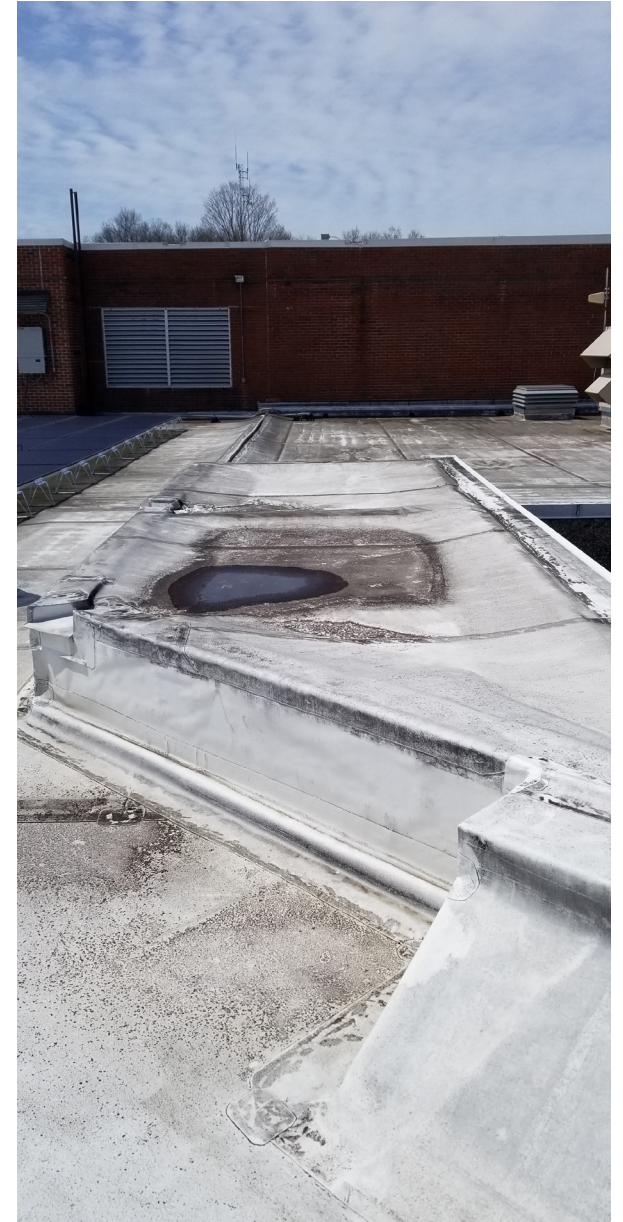
The building is clad in brick with corrugated metal and precast exposed stone panels. The brick walls show spalling, some cracking, loss of mortar, and efflorescence. The extent of this condition in some areas is concerning and it is recommended that potential causes and resolution be investigated to assure continued structural and environmental integrity of the building.

The deterioration of the brick is especially evident on some of the building corners, the chimney, and other areas both at ground level and above the roofline. Given.

The photos on this and the facing page illustrate some of the areas observed during our assessment.

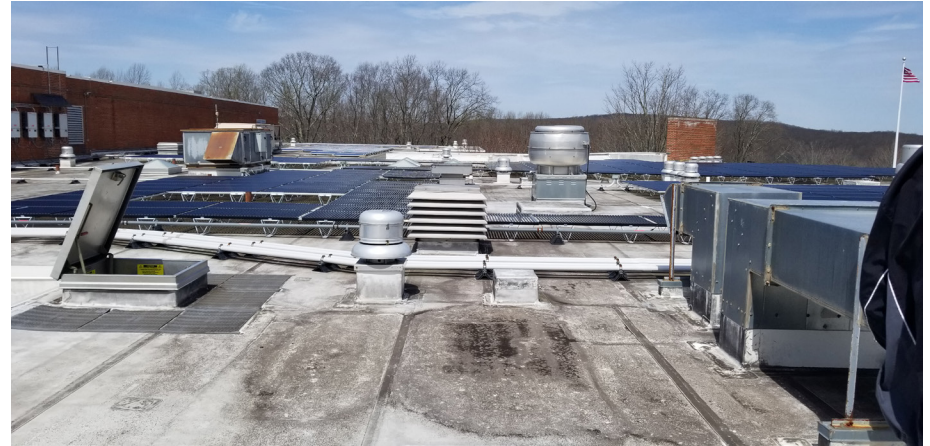
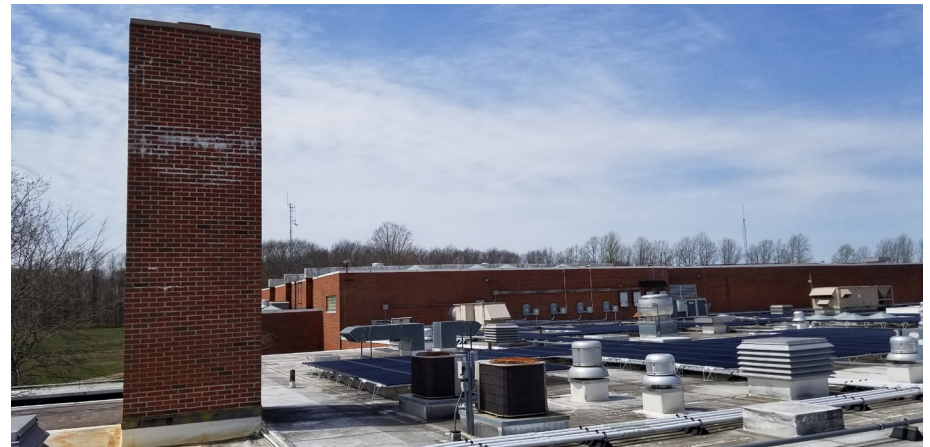
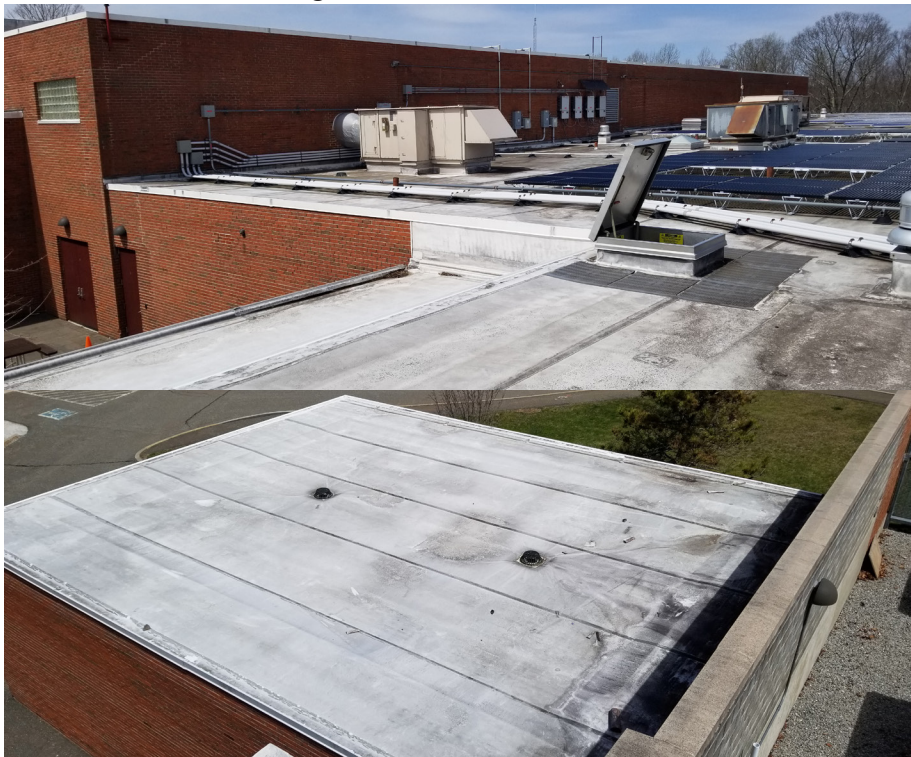
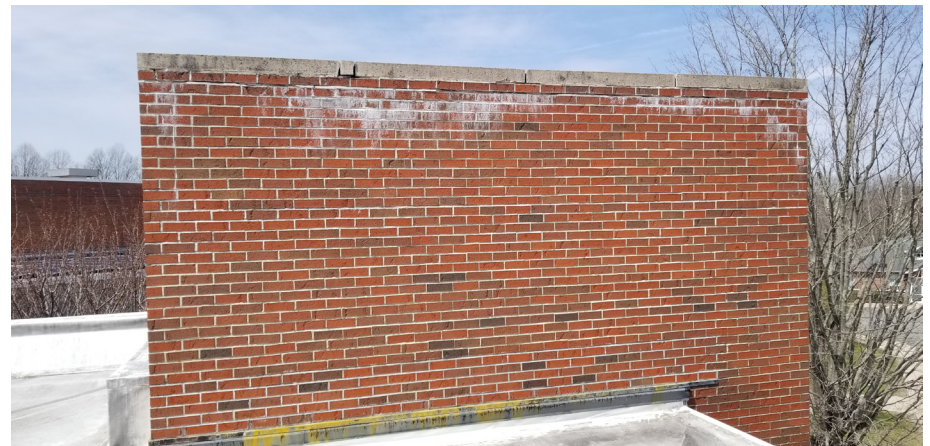
leak or point of water ingress along the north side of the roof. This shows on the interior as rot, dampness, and mold on the wall near the nurse's office. This roof should be further investigated to determine what life expectancy might be left. Roof drains need to be cleaned in various locations on the roof, and secondary scuppers are needed in many areas. It is recommended that replacement of this roof be planned for sometime in the next three to five years, unless further investigation determines it remains a sound roof and drain system.

Photos on this and the facing page give an idea of the conditions on the roof relative to effluorescence in the brick, deterioration of the chimney caps, water ponding on the roof, and the overall condition of the roofing membrane itself.

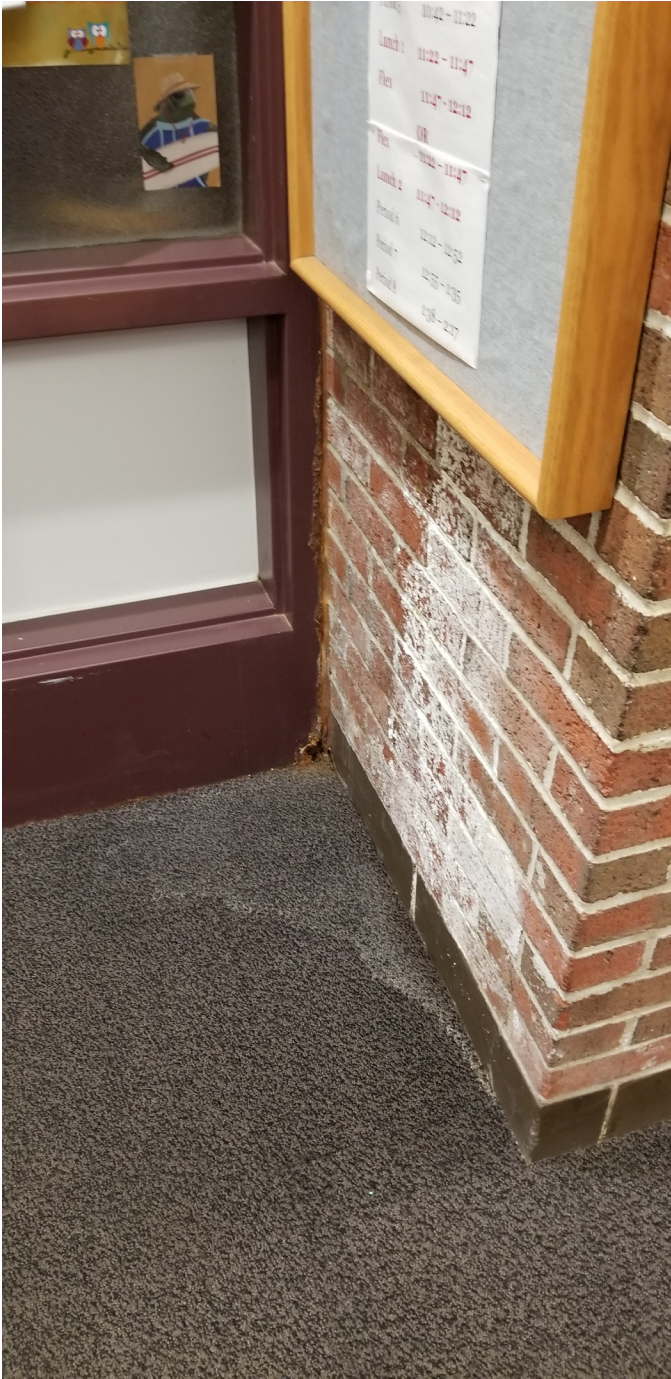
An area of concern is seen in the large photo on the facing page. This shows the damage caused by a persistent roof leak. Water has traveled beneath the roof membrane to an opening in the roof deck at one of the walls. Water has made its way down the wall near the door to the Nurse's office, where it has rotted the door frame and caused efflorescence of the brick.

It is unclear if the cause of this water infiltration has been found. This is cause for concern on a number of fronts and should be addressed as quickly as possible.

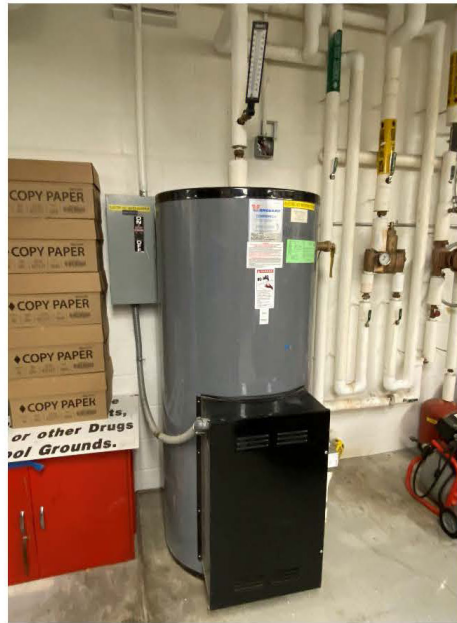
Photo # 1: Electric water heater with mixing valves.

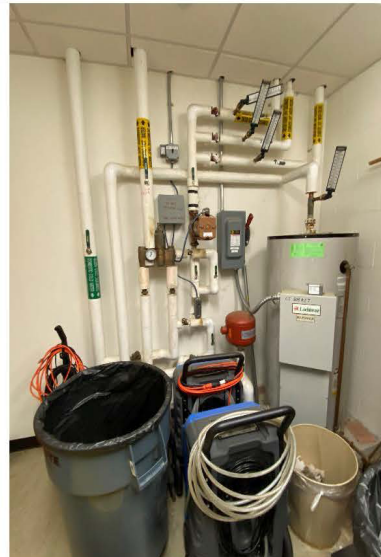
Photo # 16: Additional electric water heater in storage room.

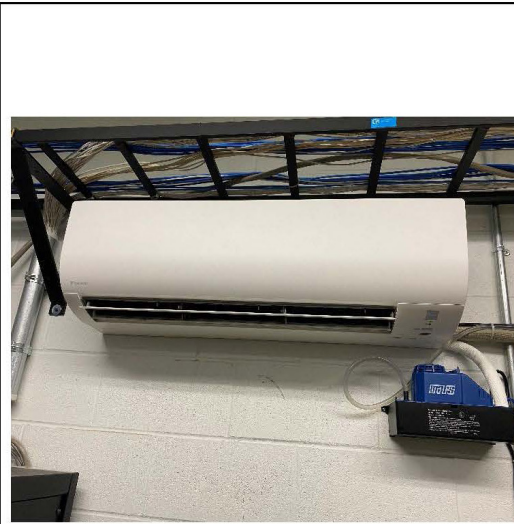
Photo # 17: AC split unit with condensate pump.

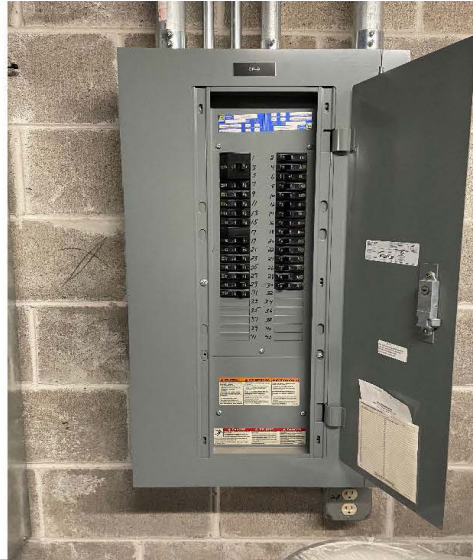
Photo # 30: - Typical "CP" for Mechanical Equipment

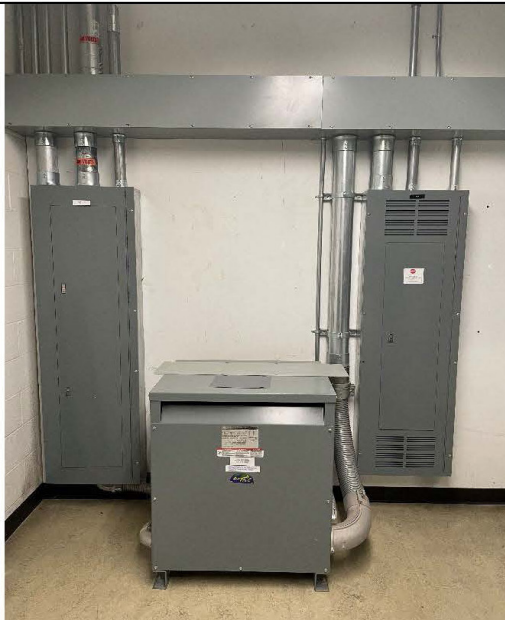
Photo # 31: - Typical Electrical Closet Panels and Distribution Transformer

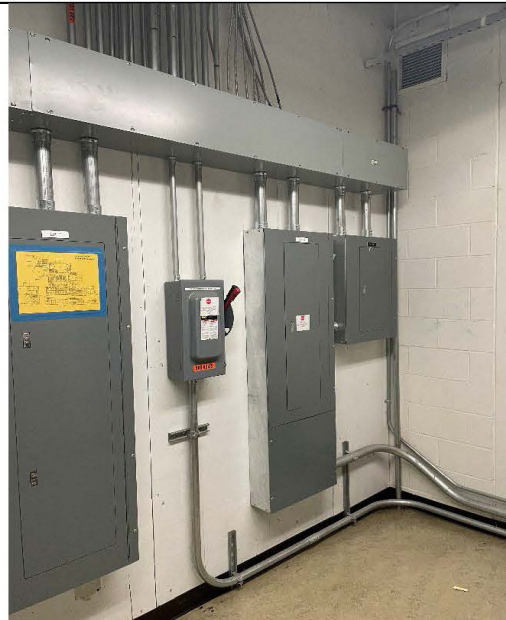
Photo # 32: - Typical Branch Panelboards – Square D (2005)

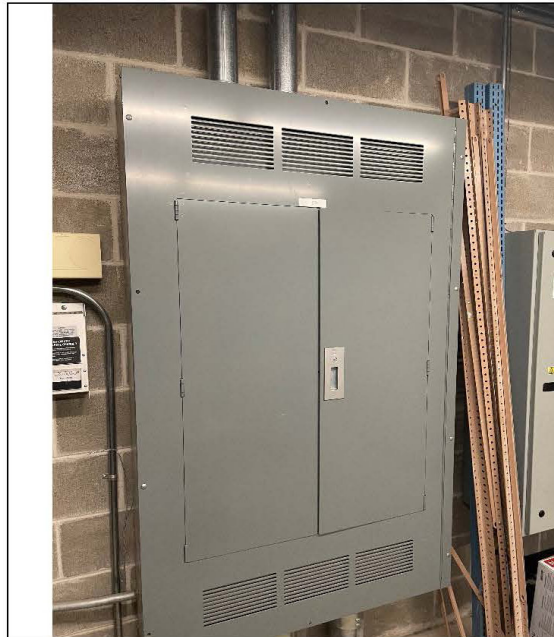
Photo # 33: - Emergency Distribution Panel “EDP”

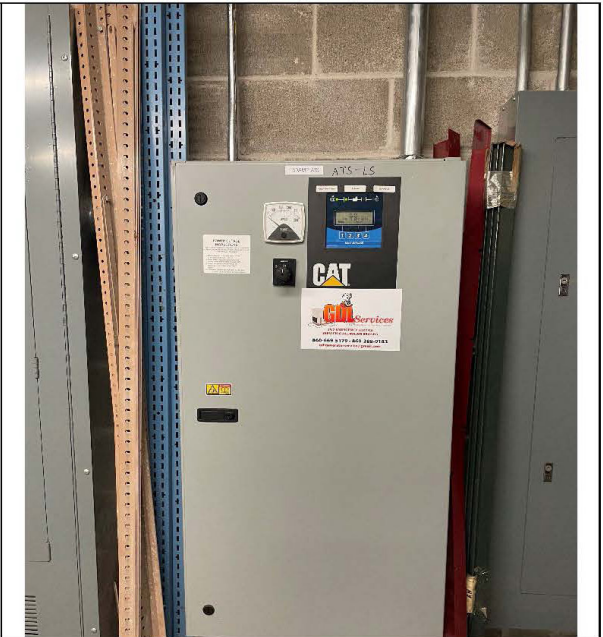
Photo # 34: - Automatic Transfer Switch – 150A “ATS-LS” (Life Safety)

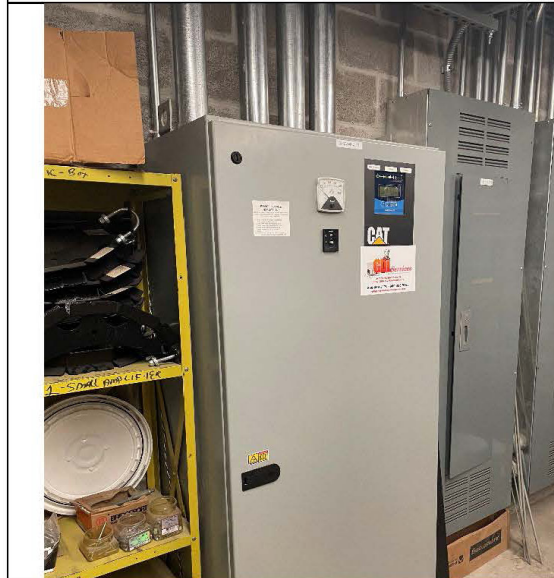
Photo # 35: - Automatic Transfer Switch – 600A (Optional Standby)

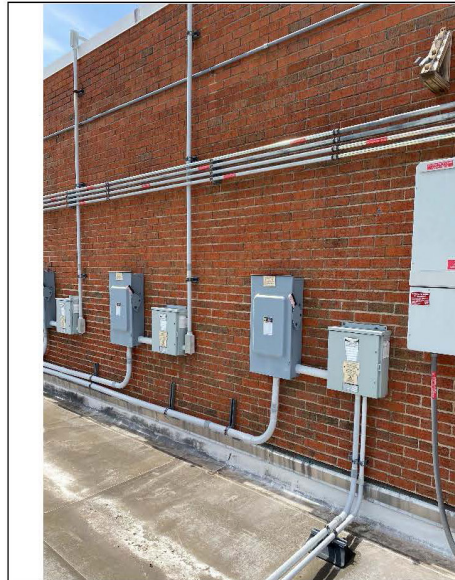
Photo # 41: - Photovoltaic System Disconnects on Roof

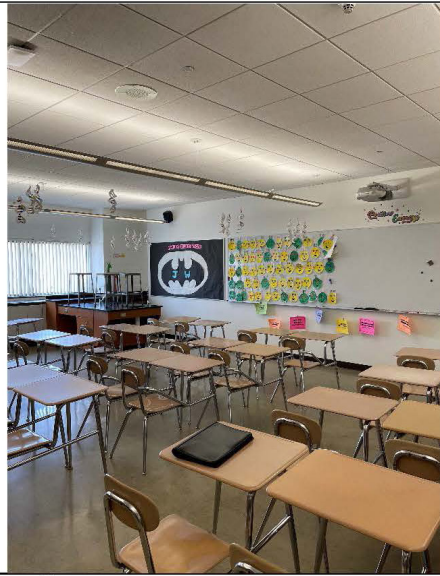
Photo # 46: - Typical Classroom Lighting

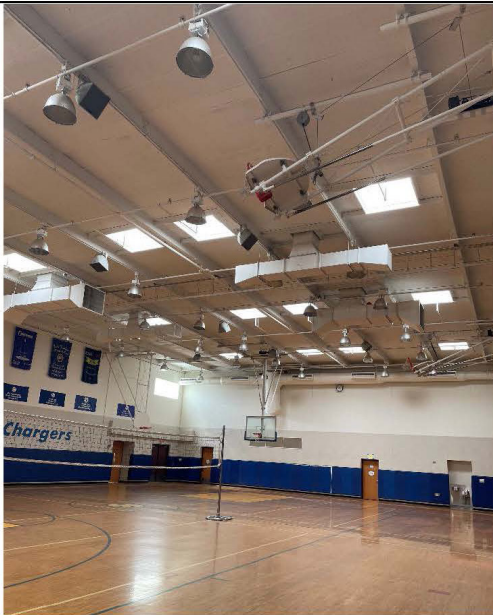
Photo # 47: - Gymnasium High Bay Lights

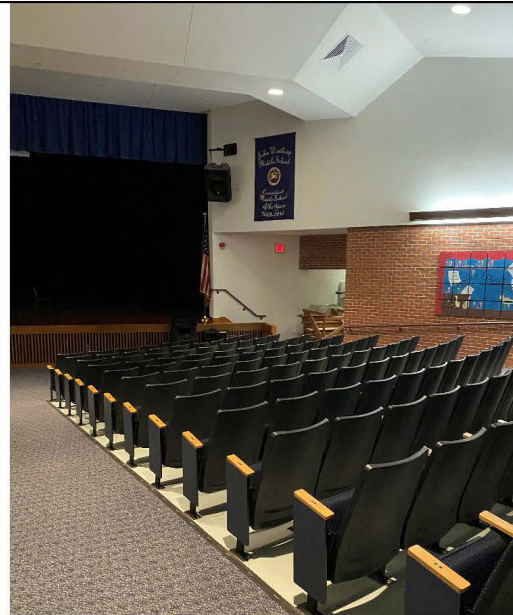
Photo # 48 - Auditorium

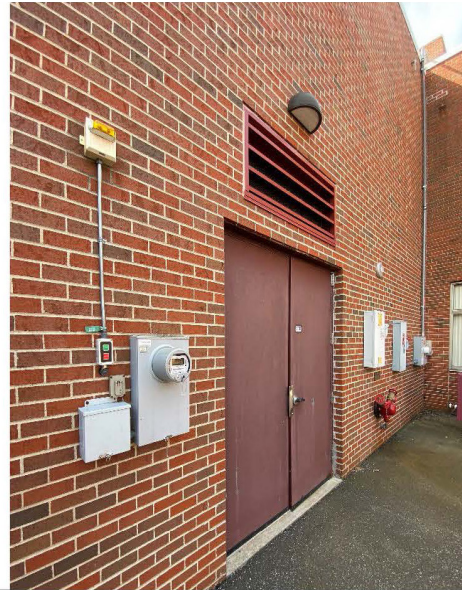
Photo # 49: - Typical Exterior Egress Light Fixture
