Root Cause Analysis of
Moisture/Water Conditions & Resulting Mold

John Winthrop Middle School

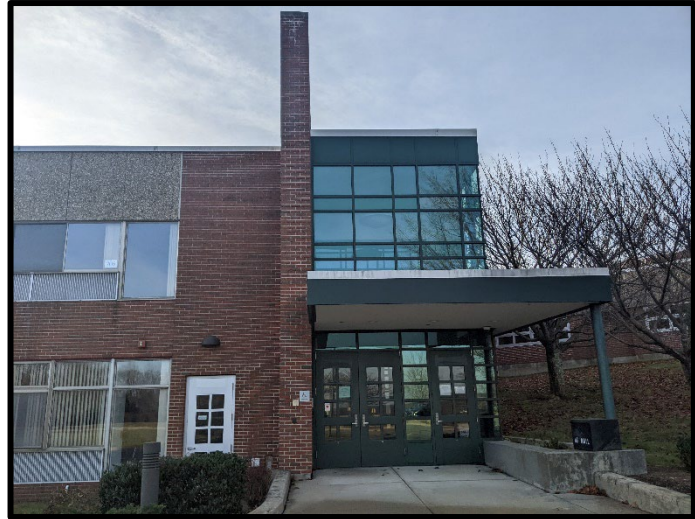
The charge for our team as outlined in the RFP is as follows:

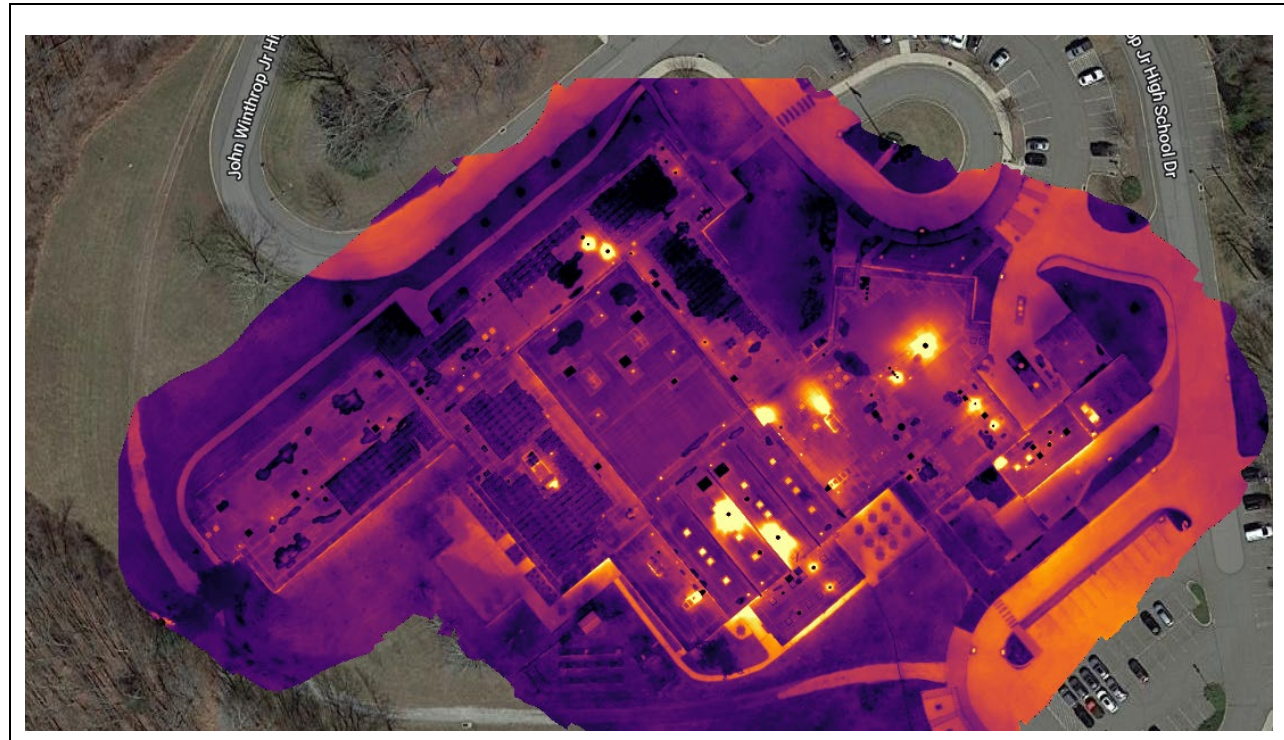
Image 1.10: Infrared Roof Plan of JWMS

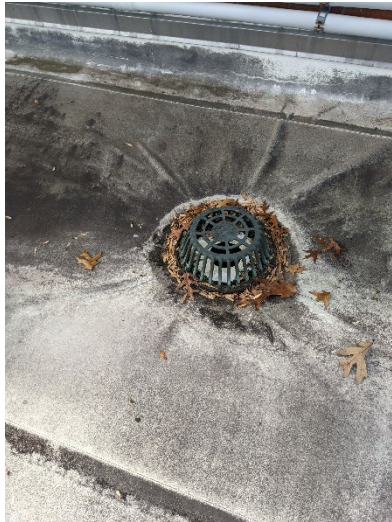
<p><u>Image 1.11: Clogged Drain</u> Roof Drains around the entire building show lots of vegetation blocking the strainer bowls. Regular maintenance needed to ensure these drains remain clear.</p>	<p><u>Image 1.12: Standing Water Around Drain</u> The sloped drain channel above the gymnasium has low spots allowing water to sit on the roof membrane rather than sloping to the drain.</p>	<p><u>Image 1.13: Clogged Scupper & Downspout</u> Significant amount of standing water is present on the loading entrance canopy due to clogged scuppers and downspouts.</p>

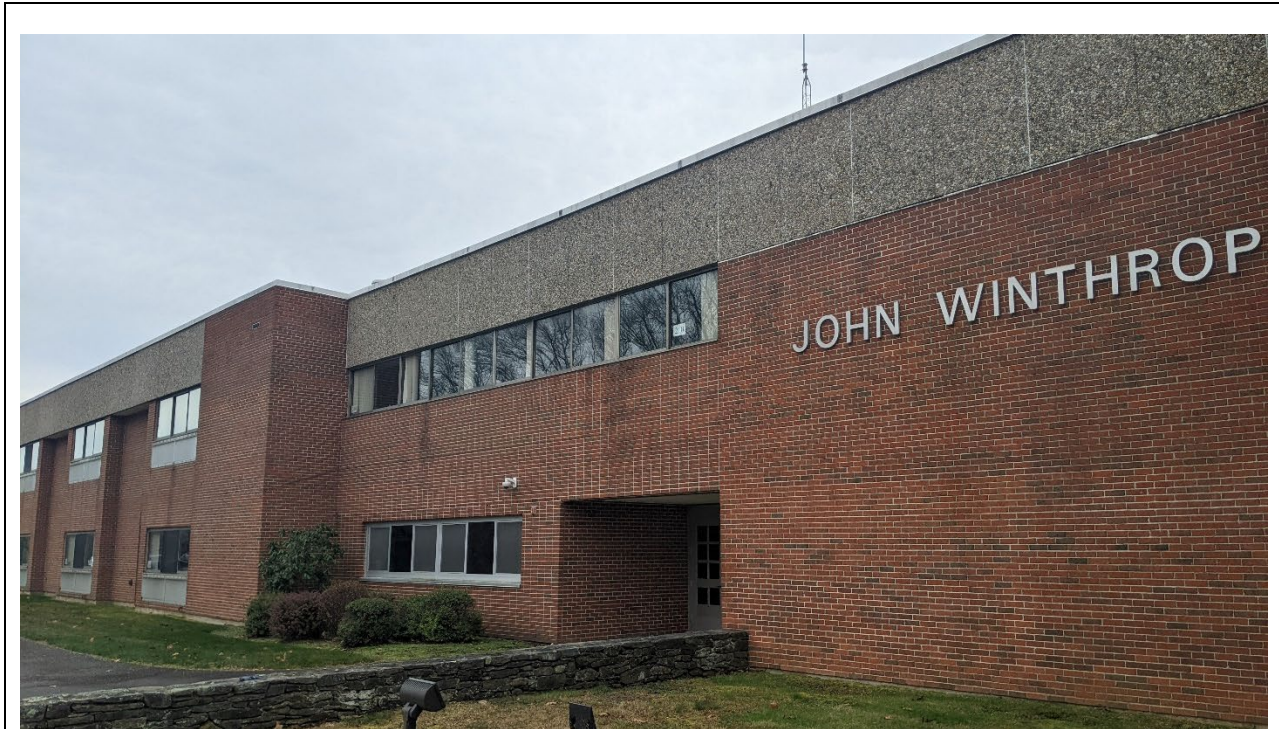
Image 2.1: North Elevation Classroom Wing

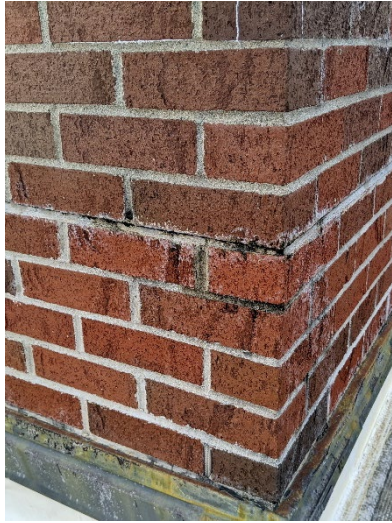
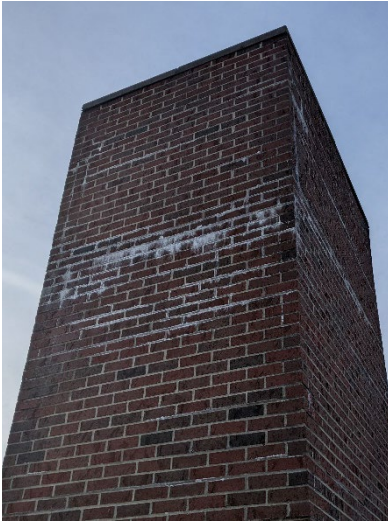
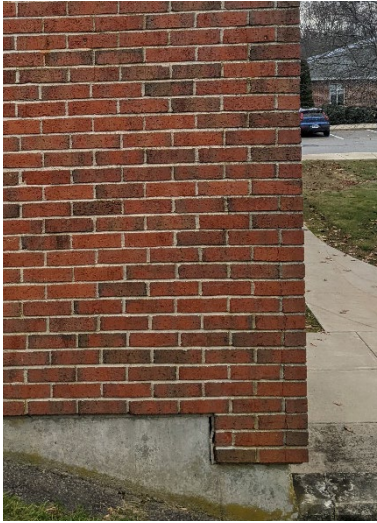
<p>Image 2.2: Failing Mortar Joints Image taken at the mechanical room chimney stack. No weeps installed within the assembly, and moisture is finding its way out through a joint.</p>	<p>Image 2.3: Efflorescence Efflorescence was observed at mechanical room chimney stack indicating moisture is present behind the assembly & leaching out through the brick.</p>	<p>Image 2.4: 1970's No Weeps No masonry weeps were observed in the walls constructed in the 1970's building. Trapped water in the cavity has no way to exit the wall except at mortar joints at the bottom.</p>

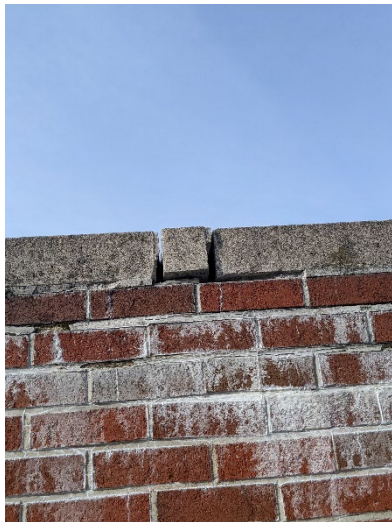
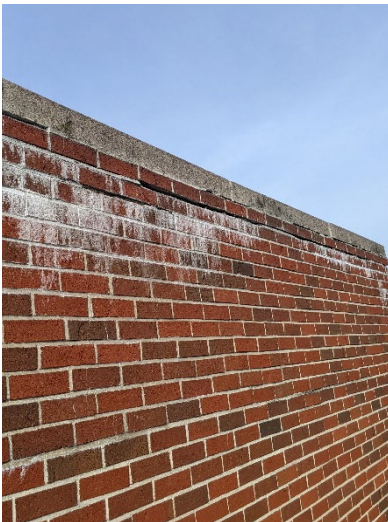
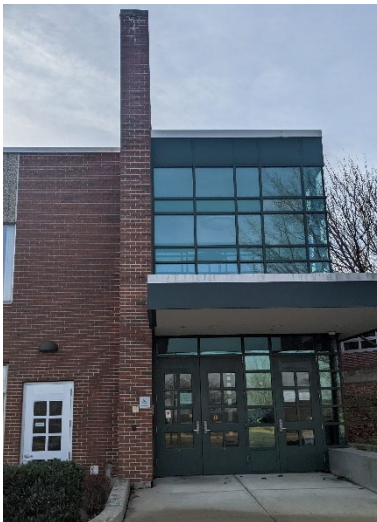
<p>Image 2.5: Failing Mortar Joints Image taken at the 2.5 story divider wall at the Main Entrance stair. Concrete cap joints have failed allowing moisture into the wall cavity down into the building. Suspected cause of 1st floor issues observed adjacent to this location.</p>	<p>Image 2.6: Efflorescence Image is of the 2.5 story divider wall at the Main Entrance Stair. Excessive Efflorescence is an indicator that moisture is within the wall assembly, and is evaporating through the brick.</p>	<p>Image 2.7: Main Entrance The image above shows the divider wall in question referenced in images 2.5 & 2.6.</p>

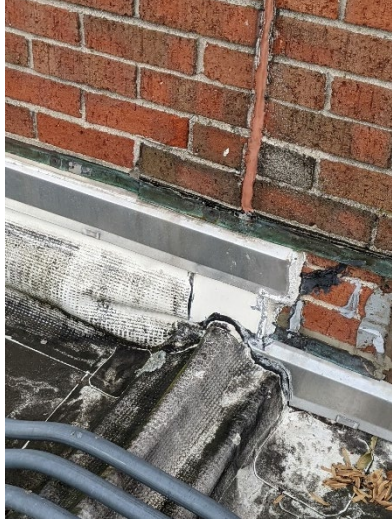
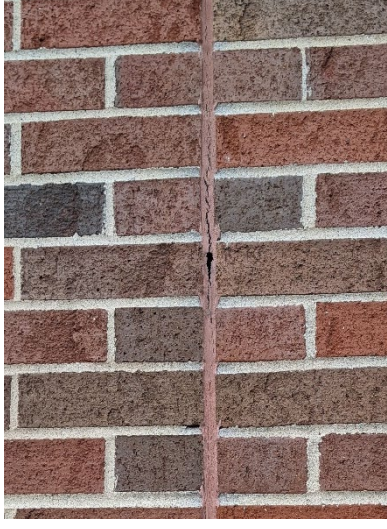
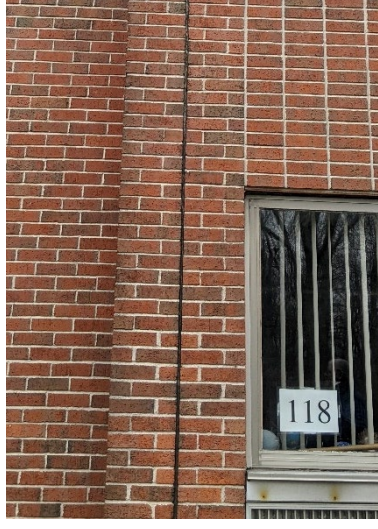
<p><u>Image 2.8: Failing Control Joints</u> Image taken at the roof to wall transition at the North Classroom Wing & the Band Room Wall. Joint sealant is showing signs of failure and is in need of replacement.</p>	<p><u>Image 2.9: Failing Control Joints</u> Image is taken at the mechanical room exterior wall on the South Elevation. Sealant joints are failing & show visible signs of dry rot & cracking. Recommended to be replaced.</p>	<p><u>Image 2.10: Failing Control Joints</u> Image taken at the North Elevation of the Classroom wing. Backer rod is all that is left of this sealant joint. Recommended to be replaced.</p>

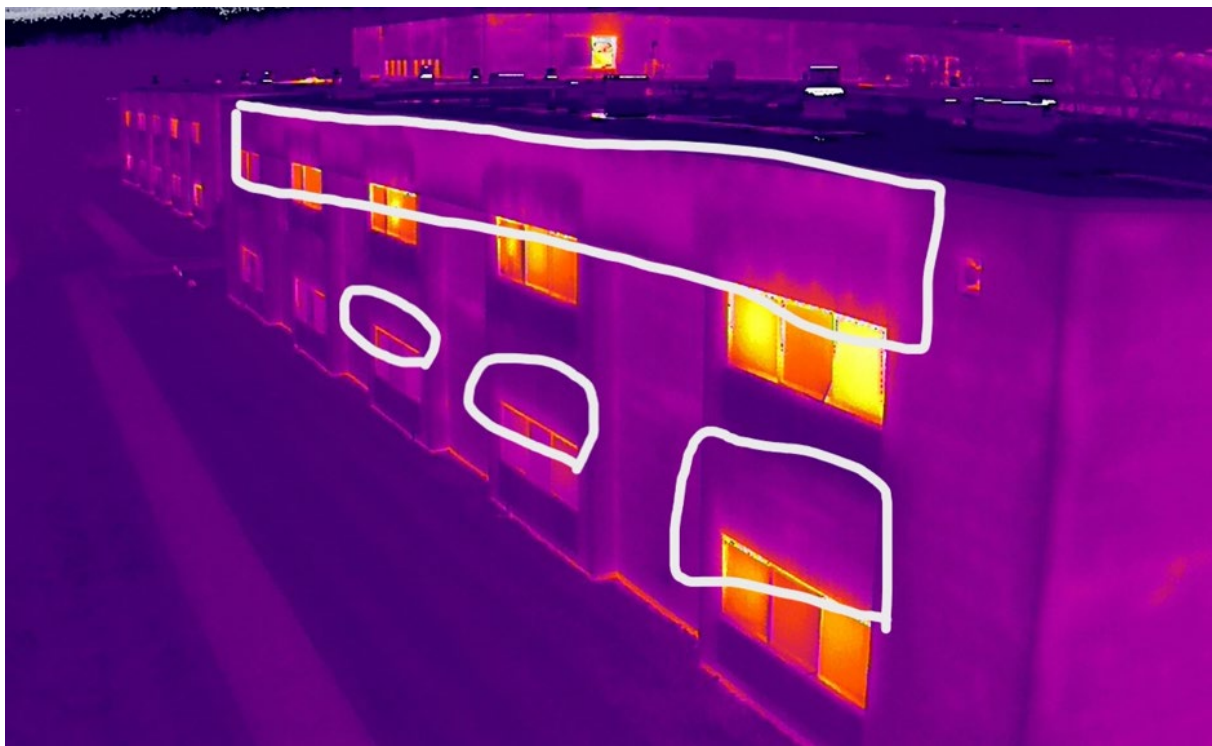
Image 2.17: Northwest Classroom Elevation Thermal Scan

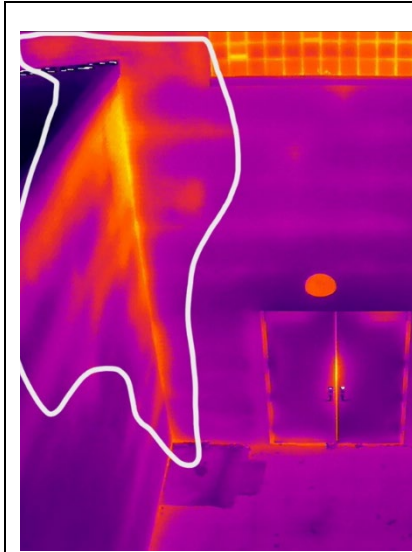
Image 2.18: S.E. Exercise Gym Corner

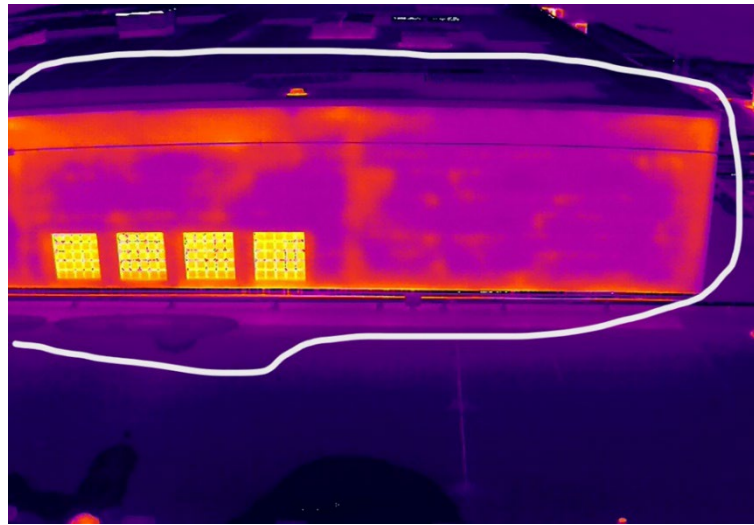
Image 2.19: North Band Room Elevation

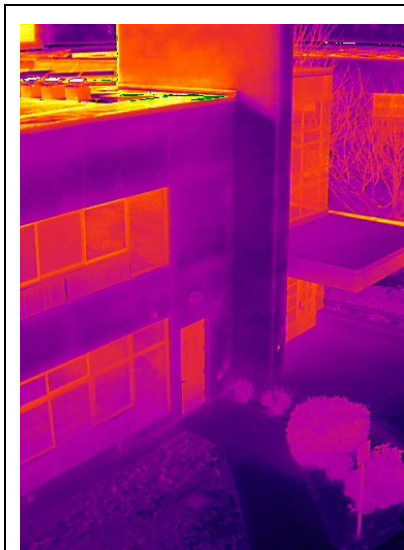
Image 2.20: Thermal of Main Entrance Divider Wall

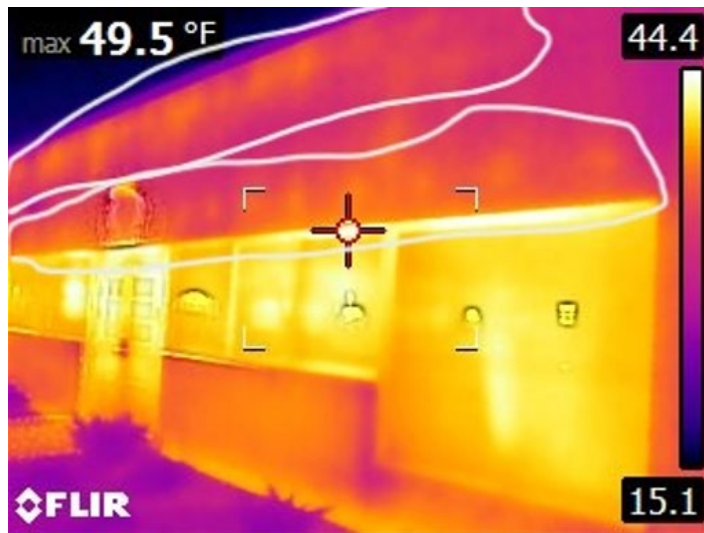
Image 2.21: Library Exterior Wall Thermal Image

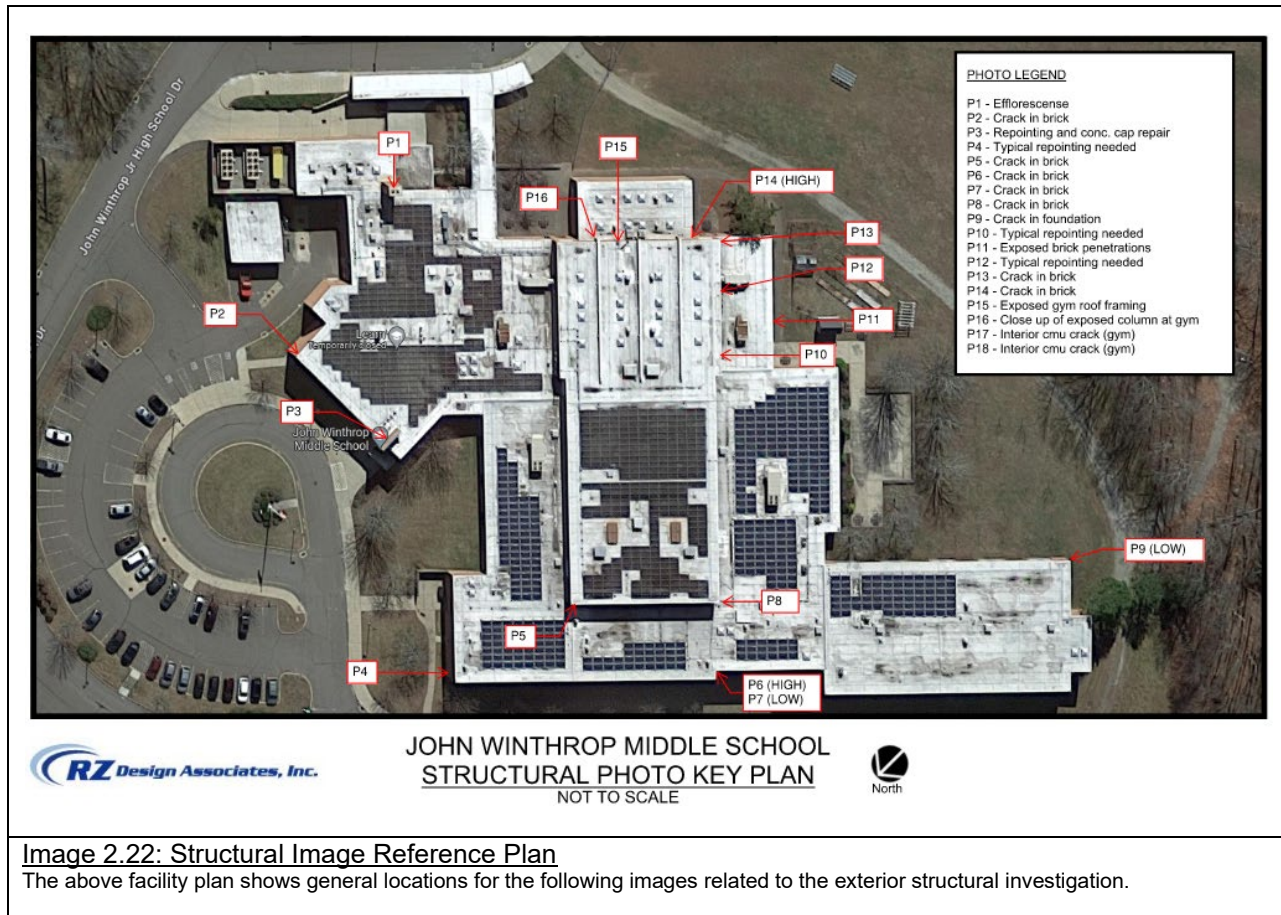
Image 2.22: Structural Image Reference Plan

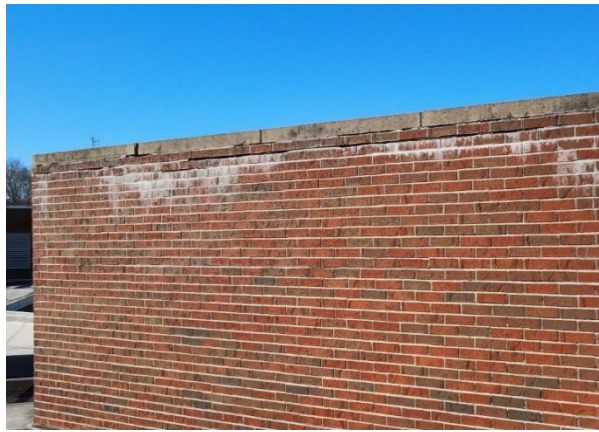
Image 2.25: P3- Repointing and Concrete Cap
Repointing of mortar joints at existing brick wall and repair of deteriorated concrete cap is required.

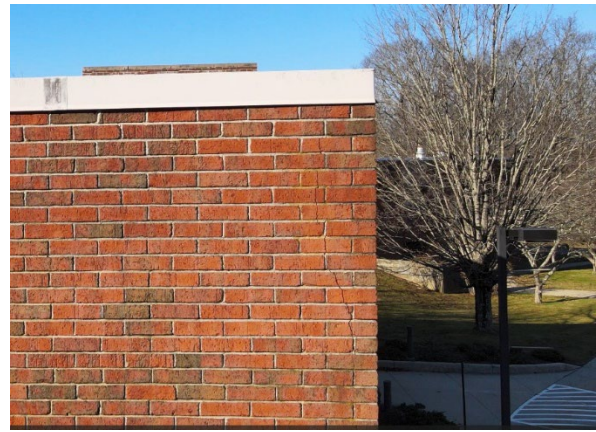
Image 2.26: P4 – Repointing of Mortar Joints
Re-pointing of mortar joints at existing brick wall.

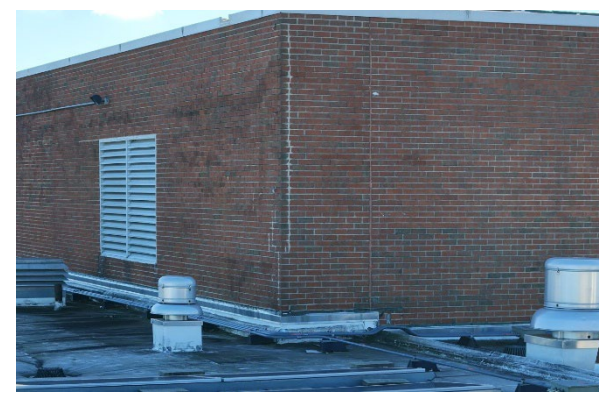
Image 2.27: P5- Repointing and Concrete Cap
Repointing of mortar joints at existing brick wall and repair of deteriorated concrete cap is required.

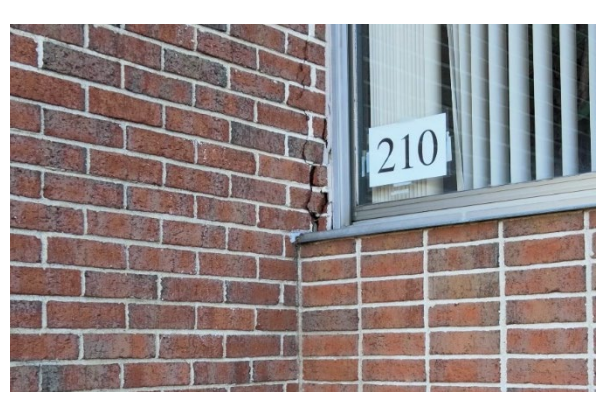
Image 2.28: P6 – Repointing of Mortar Joints
Re-pointing of mortar joints at existing brick wall.

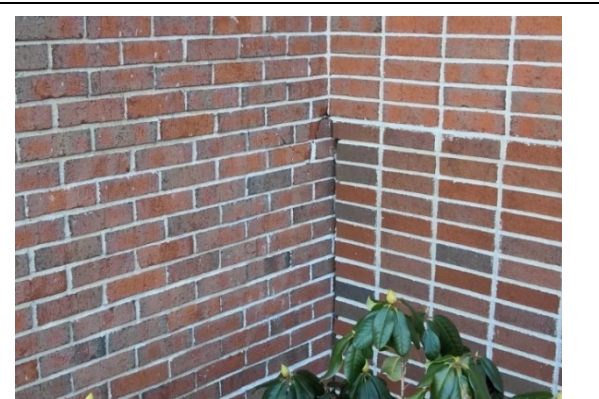
Image 2.29: P7- Repointing and Concrete
Bricks that have cracks through them need to be replaced with new brick and cracked mortar joints patched.

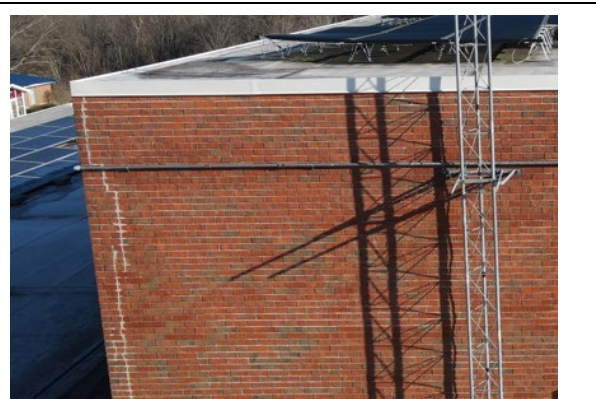
Image 2.30: P8 – Repointing of Mortar Joints
Some bricks have cracks through them, which were patched. Cracked bricks need to be replaced with new bricks.

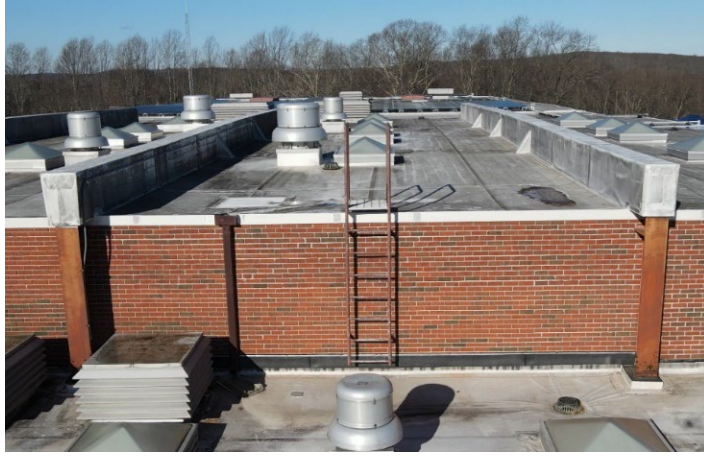
Image 2.37: P15 – Exposed Gym Roof Framing

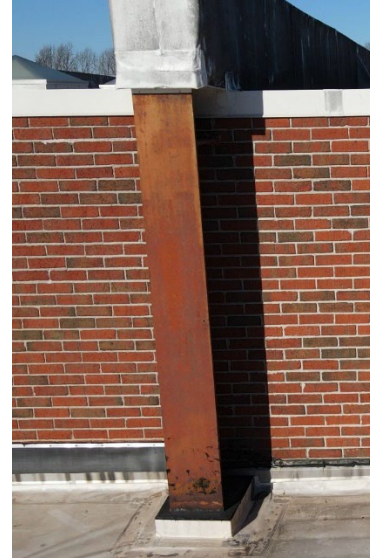
Image 2.38: P16- Exposed Column

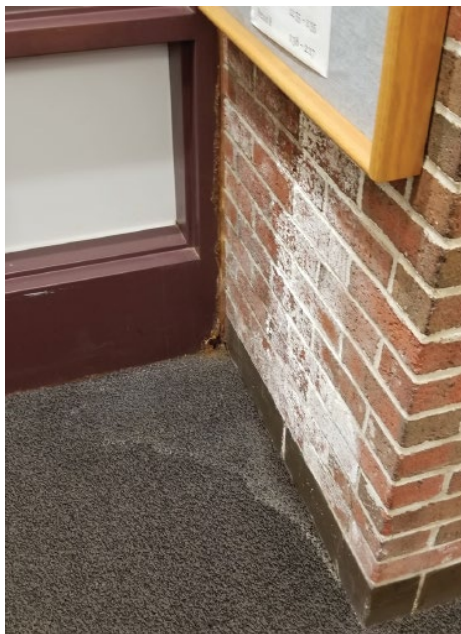
Image 3.1:Nurse Efflorescence

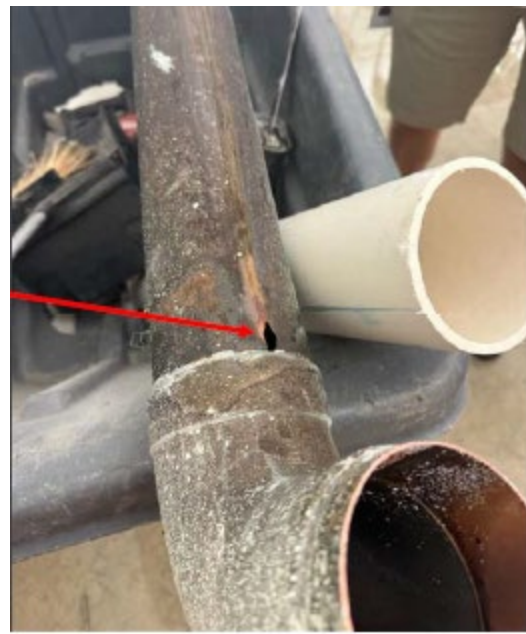
Image 3.2: Hole in Existing Roof Drain Line

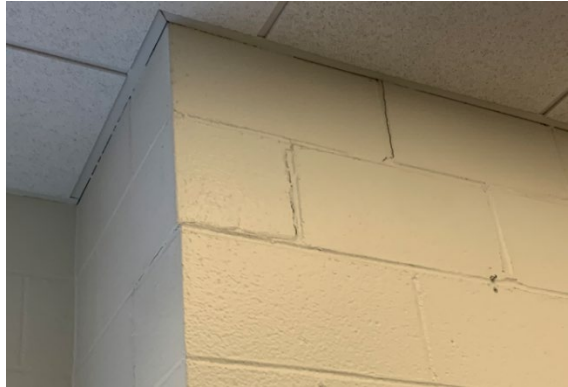
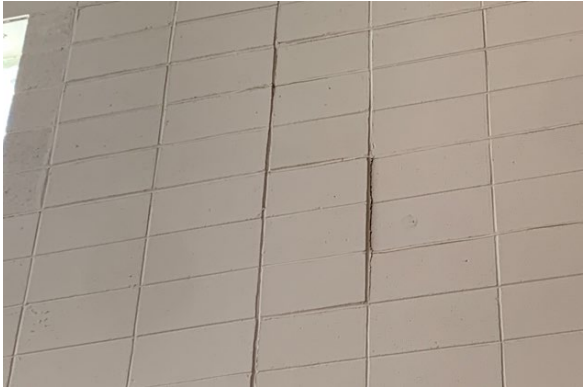
<p>Image 3.5: P19 – Stepped Cracking Stepped cracking in mortar joints in room 510. Patch and repair mortar joints.</p>	<p>Image 3.6: P20 – Vertical & Horizontal Cracks Vertical & Horizontal cracks around inward shifted masonry blocks of Gymnasium room 606. Patch vertical and horizontal mortar joint.</p>

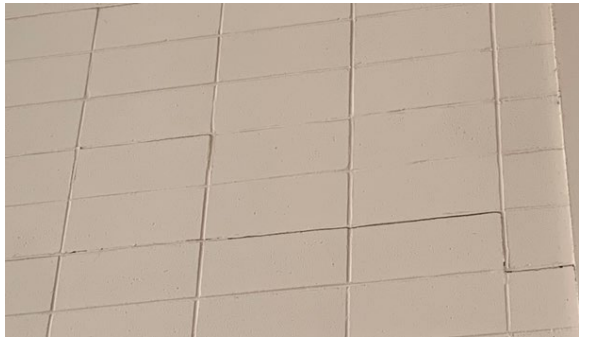
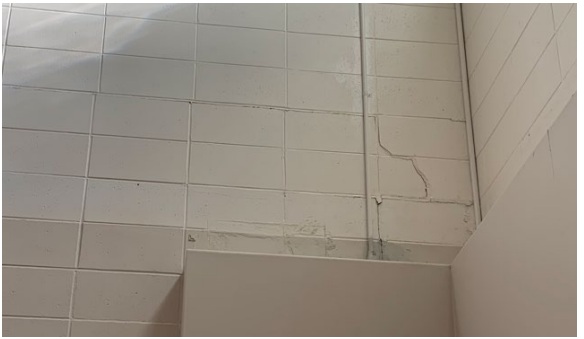
<p>Image 3.7: P21 – Stepped Cracking Stepped cracking in mortar joints of masonry block in Gymnasium room 606. Patch vertical and horizontal mortar joints.</p>	<p>Image 3.8: P22 – Stepped Cracking Stepped cracking and vertical cracks in masonry block wall & mortar joints in Gymnasium room 606 near corner of room. Patch mortar and replace any cracked block.</p>

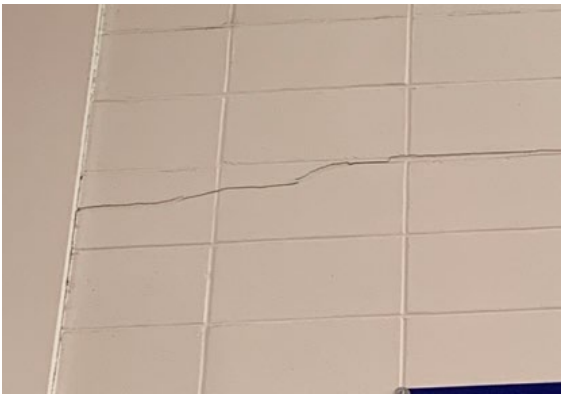
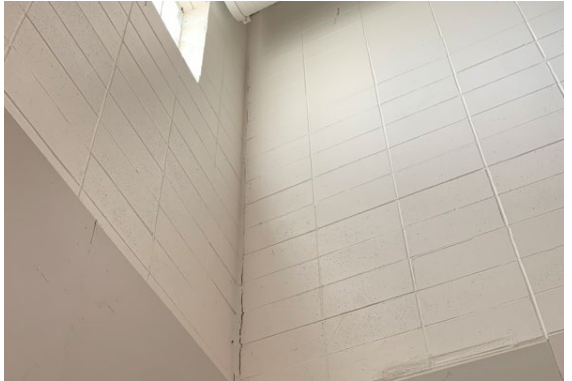
<p>Image 3.9: P23 – Horizontal Masonry Cracks Horizontal crack in masonry block along mortar joints and masonry blocks in Gymnasium 606. Patch mortar and replace</p>	<p>Image 3.10: P24 – Vertical Crack Inside Corner Vertical crack at inside corner of masonry block walls of Gymnasium 606. Patch vertical mortar joint.</p>

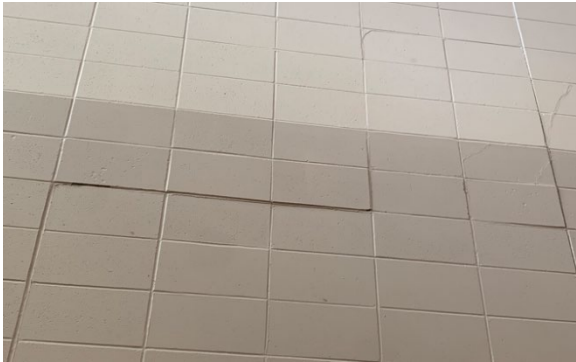
A close-up photograph of a masonry block wall. The blocks are light-colored and arranged in a grid pattern. There are several horizontal and vertical cracks in the mortar joints, creating a stepped appearance.

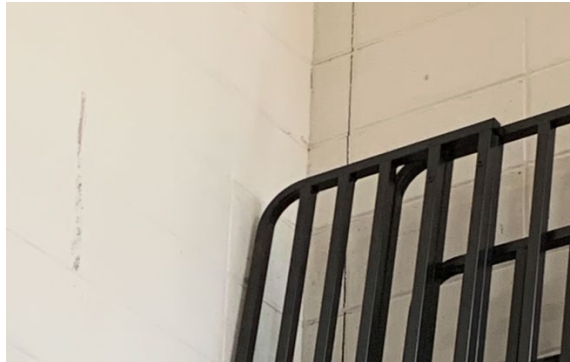
A photograph showing the inside corner of a masonry wall. A vertical crack runs down the corner joint. A black metal railing is visible in the foreground on the right side.
<p>Image 3.11: P25 – Stepped Cracking Stepped cracking in mortar joints of masonry block wall in Gymnasium 606. Patch vertical and horizontal mortar joints.</p>	<p>Image 3.12: P26 – Vertical Crack Inside Corner Vertical cracks through the inside corner of masonry walls in Gymnasium 606. Patching of vertical mortar joint is required.</p>

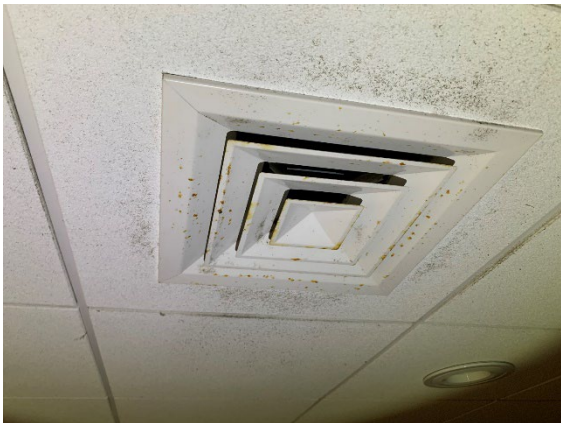
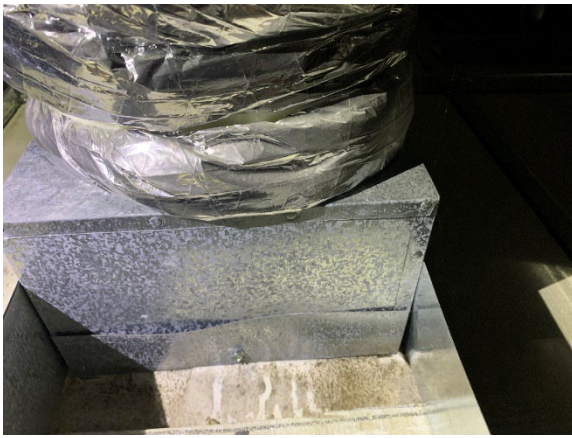
<p>Image 4.1: Rust & Condensation on Diffuser Rust formation from condensation on the diffuser and stained ceiling tiles from condensation on top of the diffuser. This occurs at a couple locations within the Main Office Suite</p>	<p>Image 4.2: Condensation on Diffuser Boot Condensation staining on the uninsulated diffuser boot and top of the diffuser.</p>

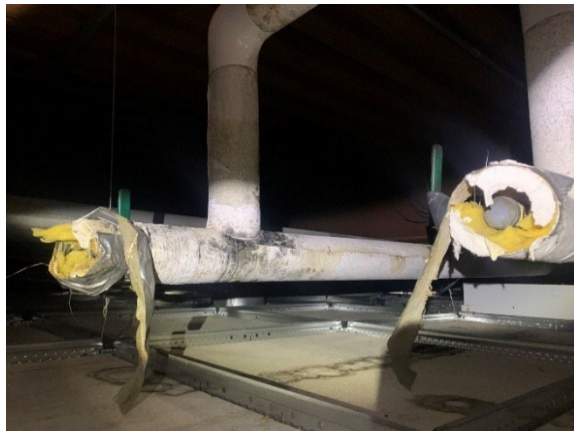
Image 4.5: Improper Insulated Pipe

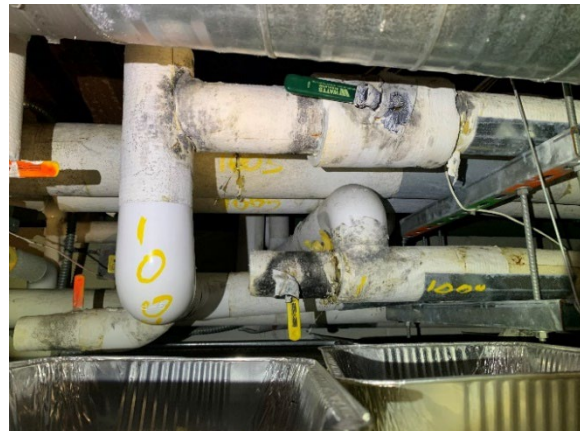
Image 4.6: Improper Insulated Pipe
