John Winthrop Middle School

The John Winthrop Middle School

1 Winthrop Road

Overview

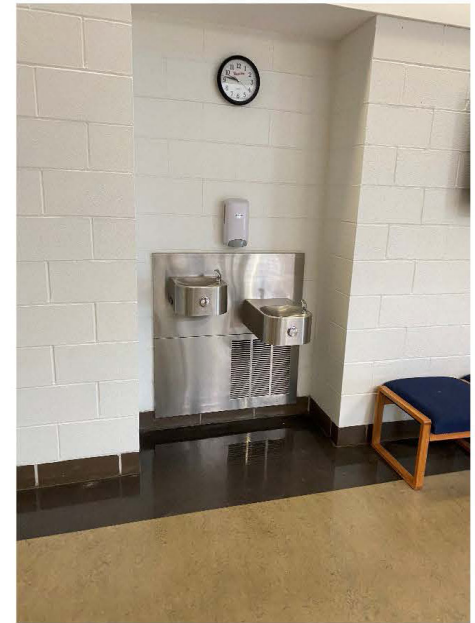
Photo # 2: Existing drinking fountain.

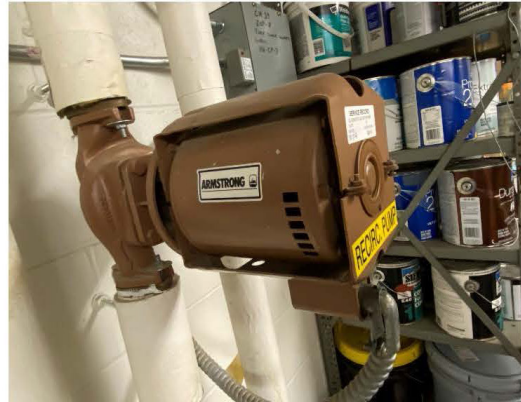
Photo # 3: Domestic hot water re-circulation pump.

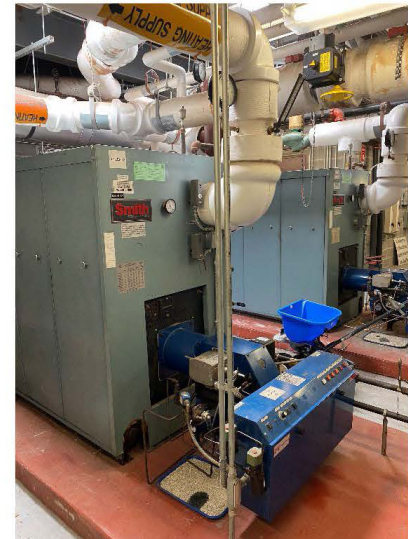
Photo # 4: Existing boiler plant.

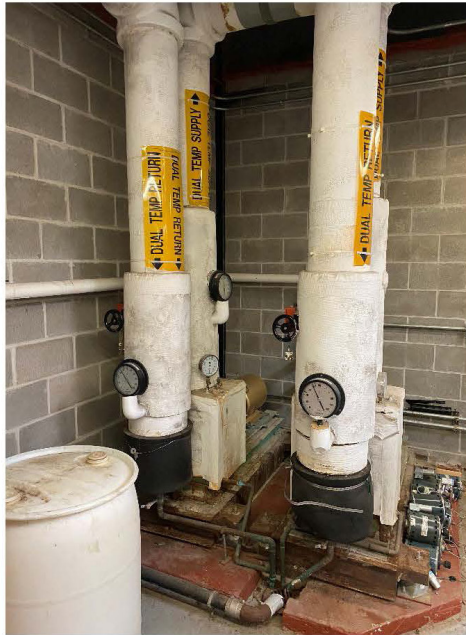
Photo # 5: Dual temp base mounted pumps.

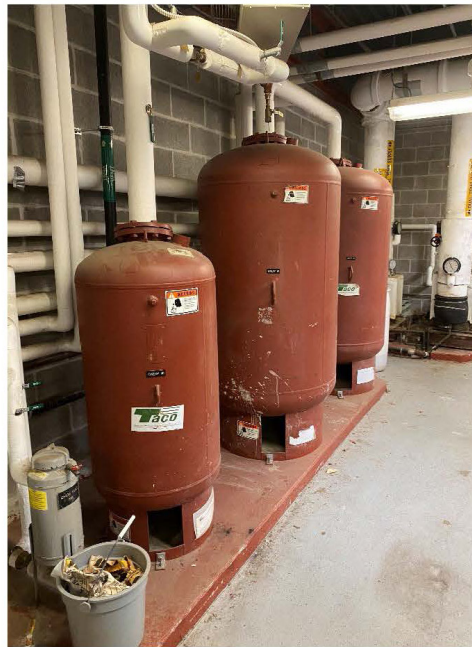
Photo # 6: Expansion tanks for hydronic systems.

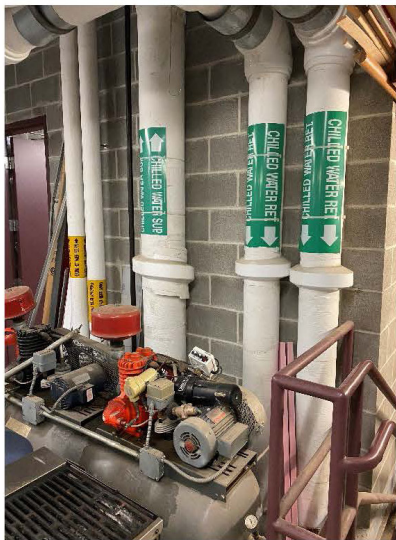
Photo # 7: Chilled water distribution piping.

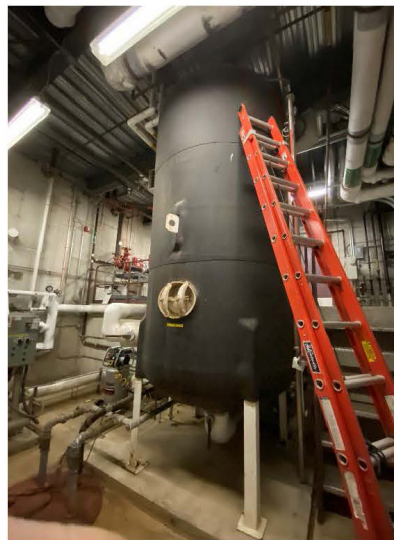
Photo # 8: Water storage tank.

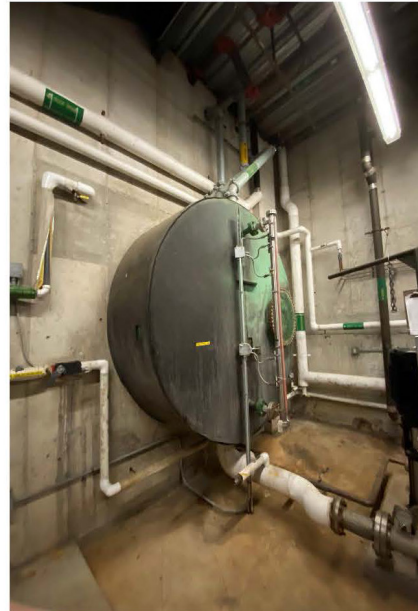
Photo # 9: Buried water storage tank.

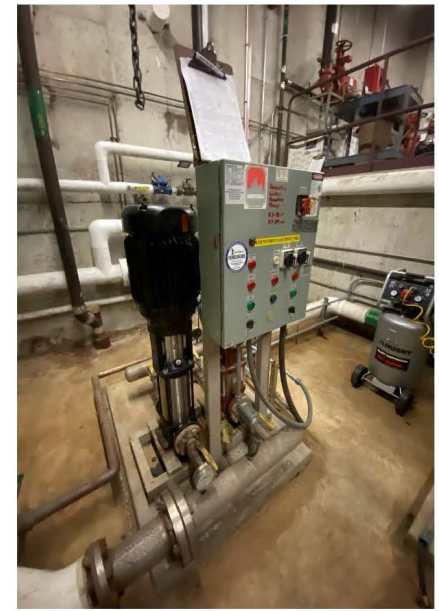
Photo # 10: Domestic water booster pump system.

Plumbing systems appear to be in fair condition. Equipment such as the booster pumps and water heaters and nearing the end of their useful life and should be replaced in the near future. A majority of the distribution piping and sanitary piping is original to the building and should be replaced if a major renovation takes place.

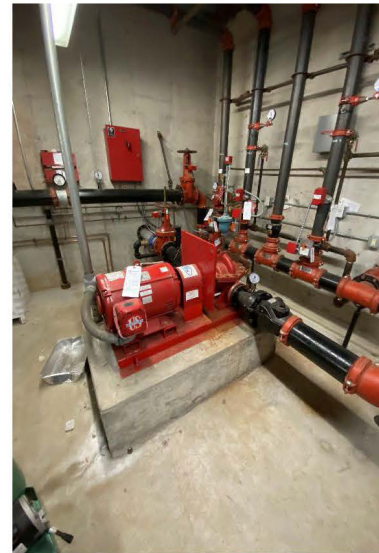
Photo # 11: Fire pump and sprinkler riser assembly.

The fire protection system appears to be in fair condition given the age of the system. Overtime, piping can start to corrode due to water chemistry and air being trapped in the system if it is not properly pitched to drains, etc. It would be recommended that if the building was renovated, the entire fire protection service assembly (including the main service into the building) be replaced with new.

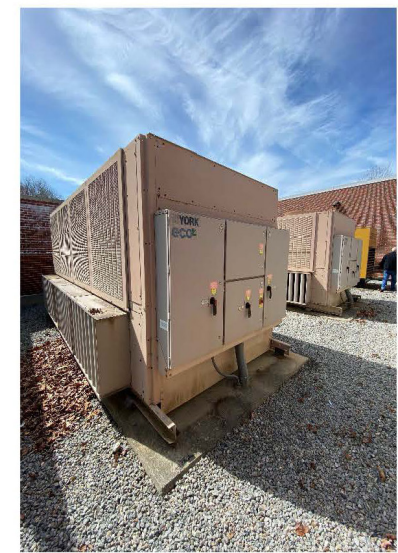
Photo # 12: Existing air cooled chillers.

The air handling units/ roof top units and unit ventilators vary in age, however, the units are operating past their useful life and should be upgraded/ replaced in the near future. Chilled water is provided to the air handling units, rooftop units and unit ventilators via (2) 130 ton air cooled chillers, located on grade next to the building. The chillers are manufactured by York and are model YCAS0138EB46YFA. The chillers appear to be operating correctly, however, as the rest of the air handling equipment, the chillers are exceeding their useful life and should be replaced in the near future.

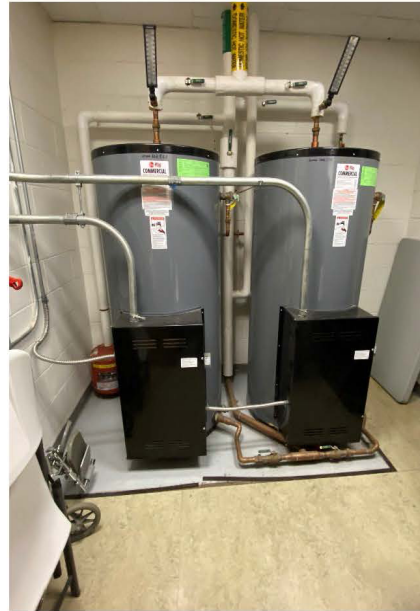
Photo # 14: Existing electric domestic water heaters.

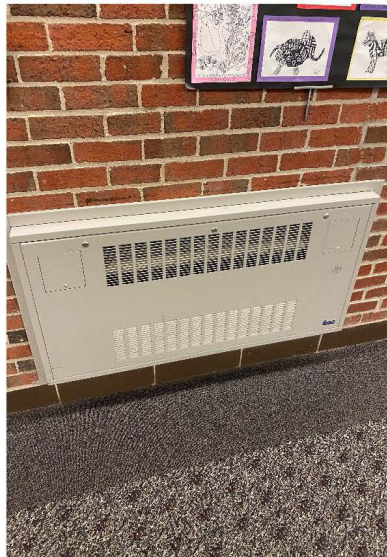
Photo # 15: Semi recessed cabinet unit heater.

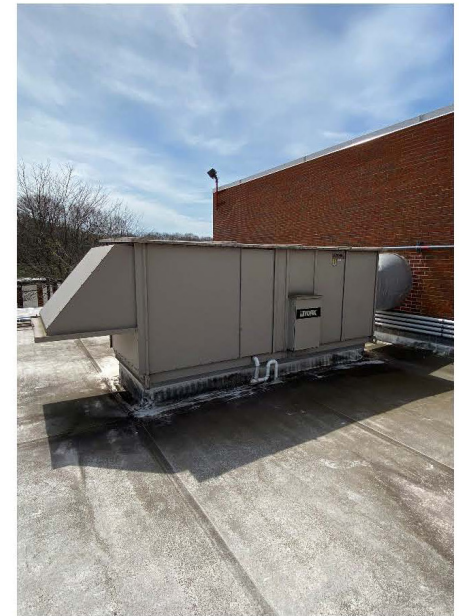
Photo # 18: Existing air handling unit.

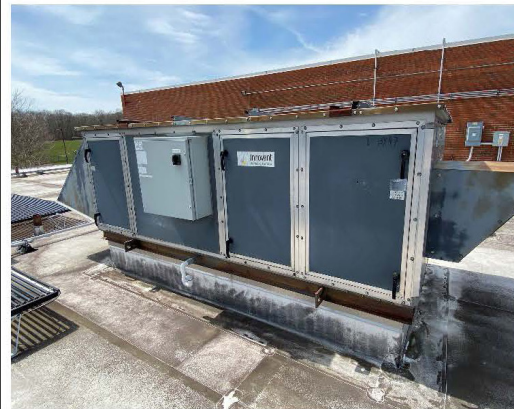
Photo # 19: Gas fired heat pumps- installed in 2017.

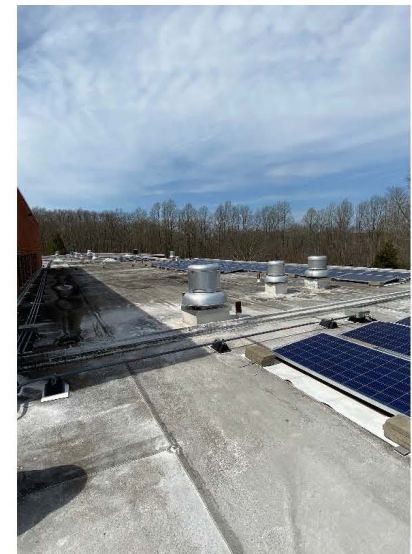
Photo # 20: Typical roof mounted exhaust fans.

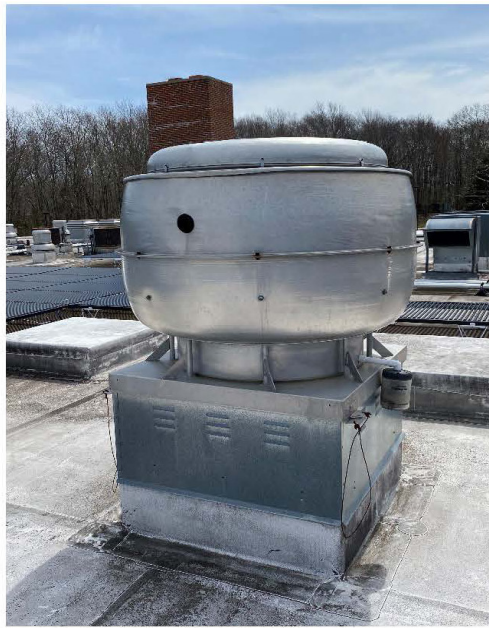
Photo # 22: Kitchen exhaust fan

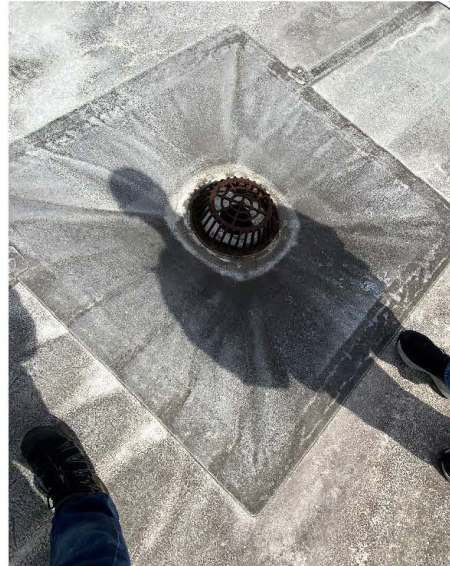
Photo # 24: Roof drain.

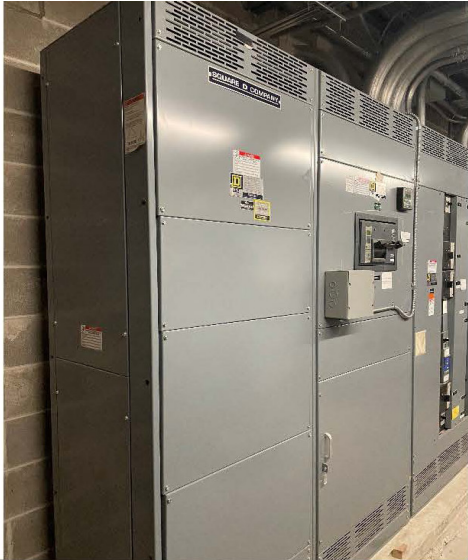
Photo # 29: - Service Entrance Switchboard in Main Electric Room

The Main Electric Service Switchboard and distribution system were installed as part of additions and renovations that were made 2005. This equipment is in excellent condition with no reported issues and should remain in service for another 15-20 years. Branch panelboards and feeders appeared in good condition with no issues reported.

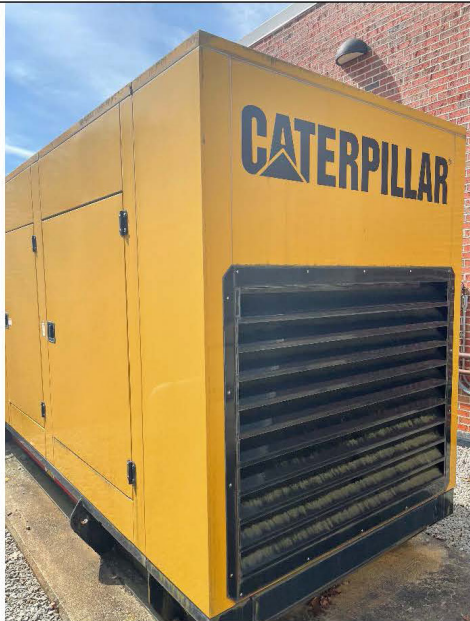
5. Emergency and Optional Standby Power – Emergency and Stand-by power to the building is provided by a 400kW/500kVA, 480/277V, 3-phase, 4-wire diesel-fired standby generator with sub-base fuel tank, manufactured by Caterpillar. A 600A generator mounted circuit breaker is fed from a 600A MCB, 480/277V Emergency Distribution Panel “EDP”. Panel “EDP” contains a 150A circuit breaker and a 500A circuit breaker, which feed the Life Safety and Optional Standby transfer switches, respectively. Life Safety transfer switch “ATS-LS” is wired to a 150A MCB, 480/277V Life Safety distribution panel, which feeds branch panels throughout the building for emergency lighting. The Optional Standby transfer switch, marked “600AMP ATS”, is wired to a 500A MCB, 480/277V 2-section distribution panel “ESB-1”. “ESB-1 (SECT. 1)” feeds “CP” branch panels, AHU’s, and various other pieces of mechanical equipment. “ESB-1 (SECT. 2) feeds RTU’s, well pumps, kitchen panel “KP-1” and transformer for panel “EOP”. “EOP” is a 100A, 208/120V panel that feeds various 120V and 208V mechanical equipment loads.

Photo # 37: - 400kW/500kVA Diesel Powered Generator with Sub-Base Fuel Tank

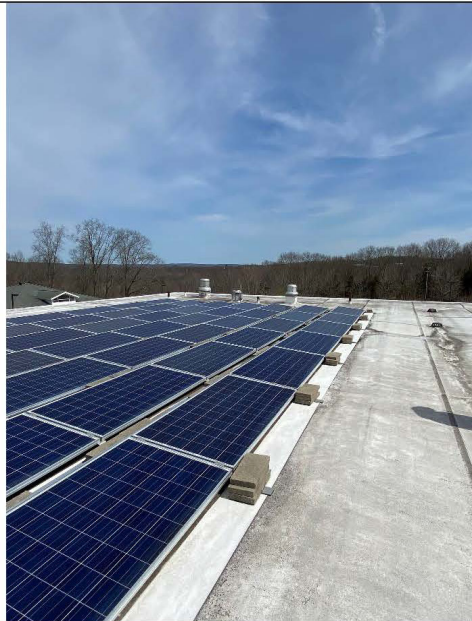
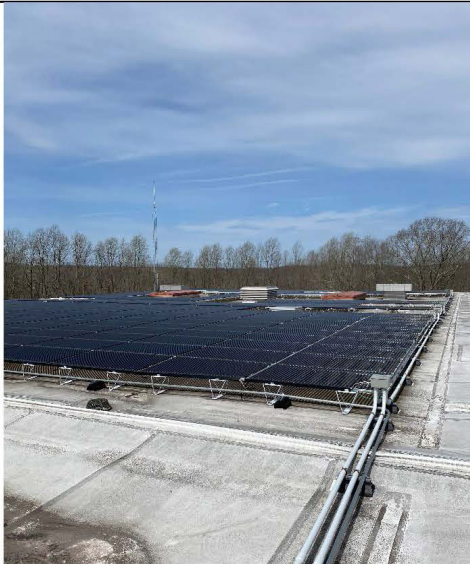
6. Photovoltaic System – The PV system is of the grid-connected type and does not include battery/back-up storage or secondary electrical generation devices. The system utilizes solar arrays, installed on the various roof structures and produces AC power at 480V into local services via inverters mounted on the roof. The system disconnect and meters and are located at the ground level exterior, close to the utility meter. This system appears to be functioning properly with no issues reported.

Photo # 38: - Solar Panels on Roof

Photo # 39: - Solar Panels on Roof

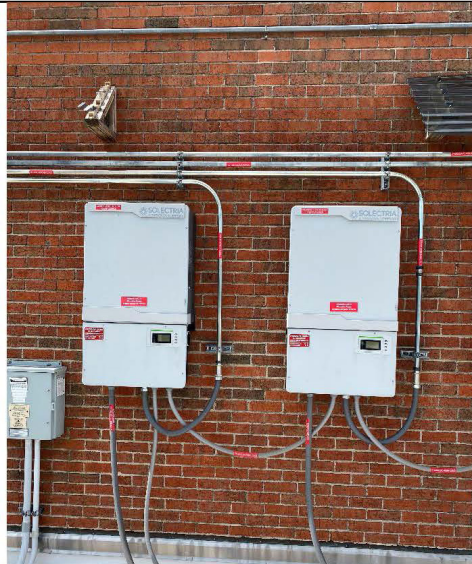
Photo # 40: - Typical Photovoltaic System Inverters on Roof

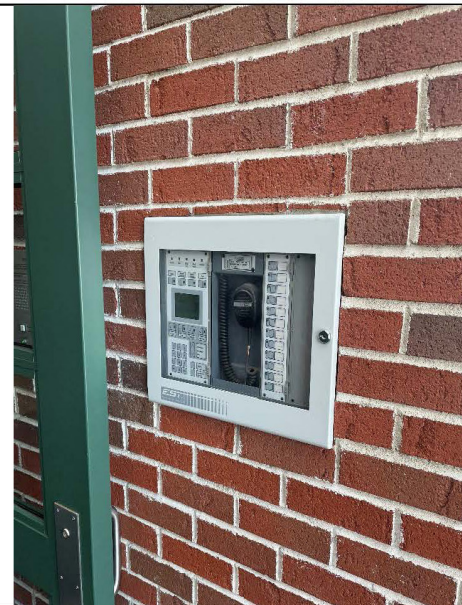
12. Fire Alarm System – The building is equipped with an Edwards EST3 addressable fire alarm system control panel with voice evacuation. The fire alarm control panel is located in the maintenance work room and contains a microphone handset to allow annunciation over the building’s speaker/horn-strobe devices. Remote annunciator panels with voice evac were observed in the main entrance vestibule and administration offices. There are also a voice evacuation panels with microphones in the gymnasium and auditorium. Fire alarm speaker/strobe coverage throughout the building appears sufficient. Locations of manual pull stations are compliant. All fire alarm devices appeared to be mounted at the correct ADA height. Monitor and control modules for duct smoke detectors were not observed.

Photo # 50: - Fire Alarm System Control Panel
