John Winthrop Middle School

The John Winthrop Middle School

1 Winthrop Road

Overview

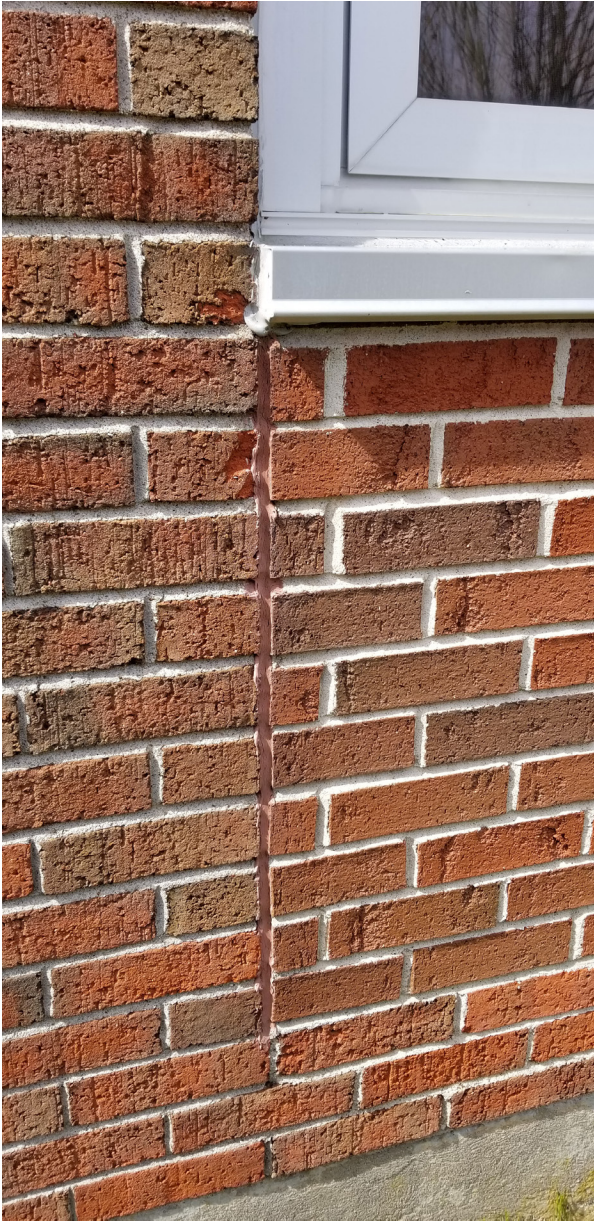
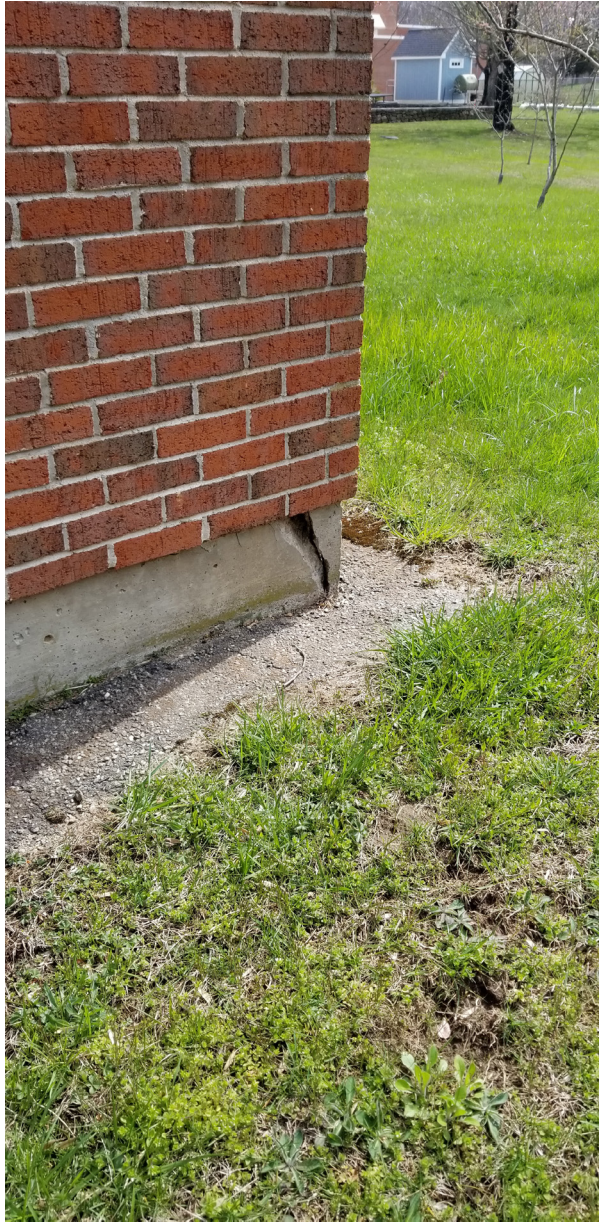
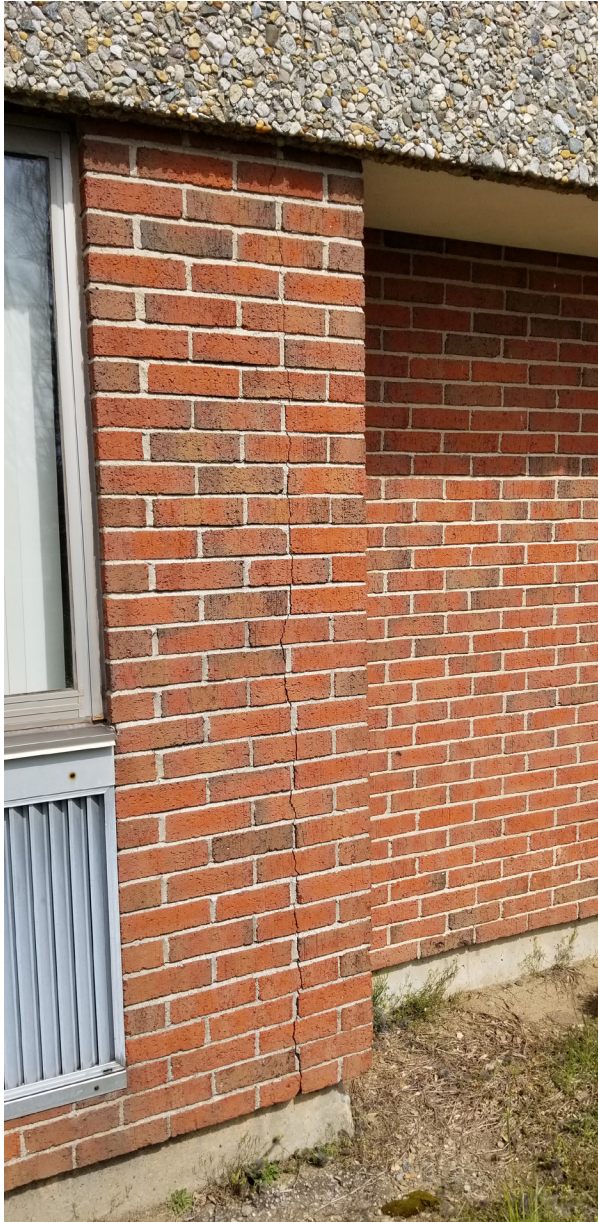
The building is clad in brick with corrugated metal and precast exposed stone panels. The brick walls show spalling, some cracking, loss of mortar, and efflorescence. The extent of this condition in some areas is concerning and it is recommended that potential causes and resolution be investigated to assure continued structural and environmental integrity of the building.

The deterioration of the brick is especially evident on some of the building corners, the chimney, and other areas both at ground level and above the roofline. Given.

The photos on this and the facing page illustrate some of the areas observed during our assessment.

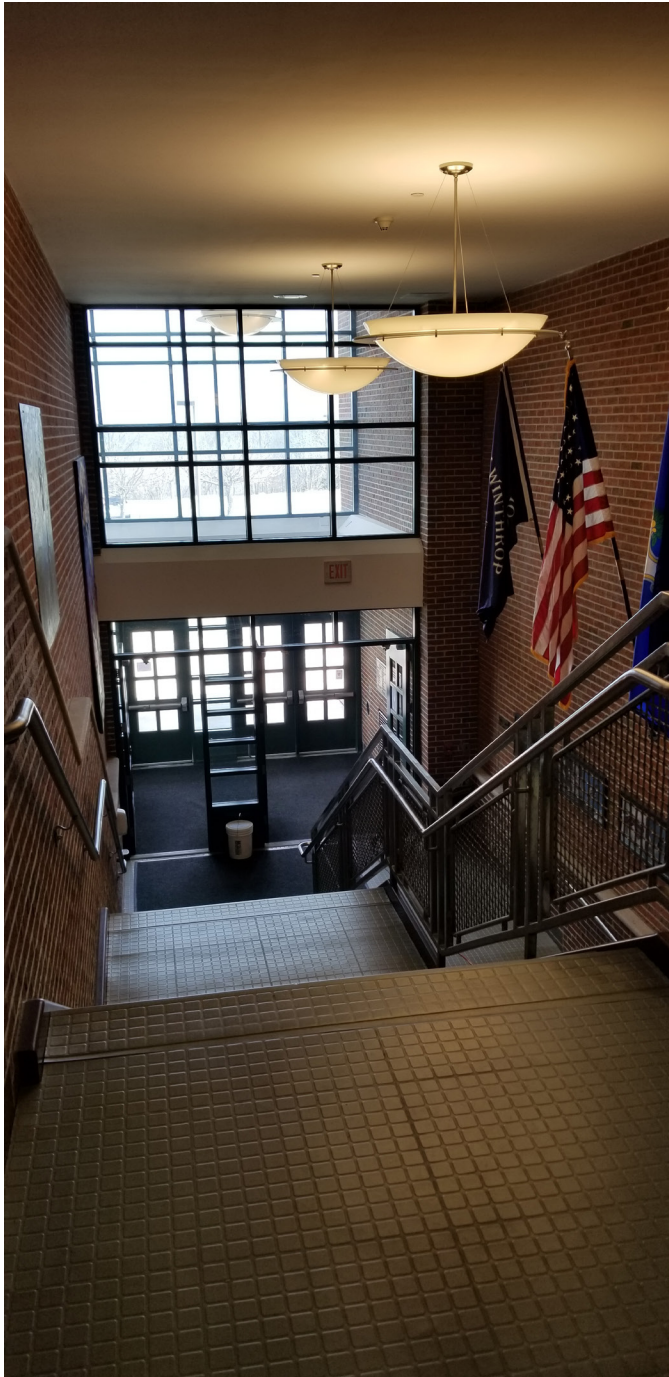
An area of concern is seen in the large photo on the facing page. This shows the damage caused by a persistent roof leak. Water has traveled beneath the roof membrane to an opening in the roof deck at one of the walls. Water has made its way down the wall near the door to the Nurse's office, where it has rotted the door frame and caused efflorescence of the brick.

Additional signs of water infiltration are shown in the smaller photo on the facing page. This is in one of the stair towers and appears to be caused by water penetrating the wallboard.

It is unclear if the cause of this water infiltration has been found. This is cause for concern on a number of fronts and should be addressed as quickly as possible.
